## Manistee Anderson Creek Project

June through October, 2007

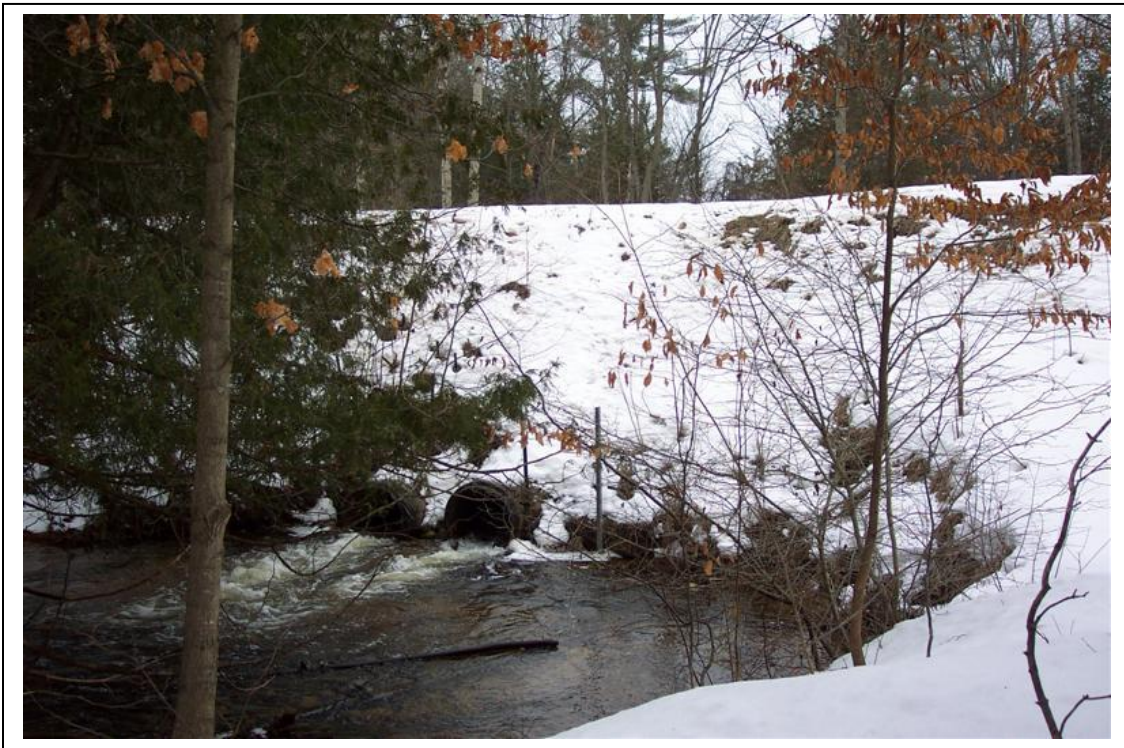
An important cold water tributary to the middle section of the Manistee River, Anderson Creek holds rainbow and brown trout and was negatively impacted by the Number 6 Road Crossing southeast of Buckley. Twin concrete culverts and steep, eroding embankments impounded water upstream and caused scour below the road. The old culverts were removed, the channel was realigned with a larger, longer tube, and the road surface was paved to control road runoff.

Small, short culverts caused both a plunge pool at the outlet and embankment erosion along the road shoulder.

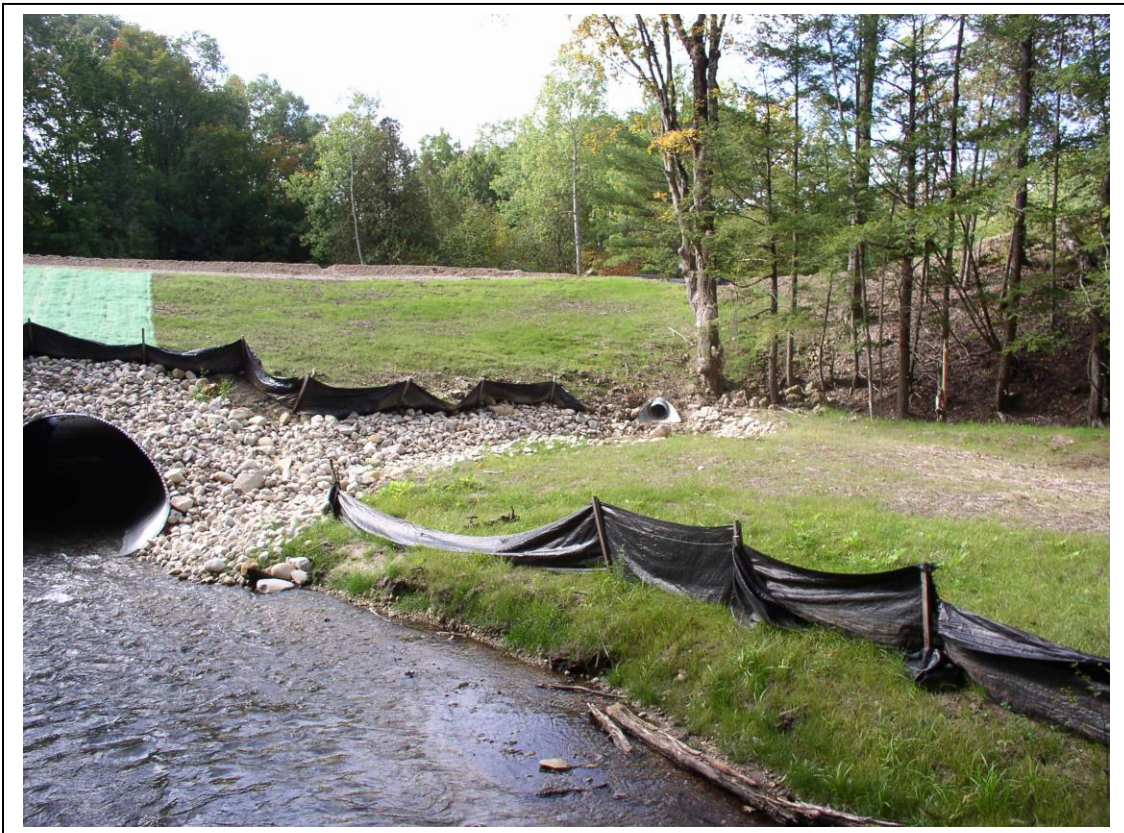
The completed site includes a wider culvert, flatter side slopes, and a paved road with runoff control visible in the center of the photograph.

- removal of existing culverts
- Installation of larger, longer culvert
- road and ditch runoff control
- pavement and curbing
- revegetation
- stream channel enhancement
- streambank stabilization
