# Baker Creek & 56<sup>th</sup> Street Project Pere Marquette River Watershed September 2012

# Baker Creek and 56<sup>th</sup> Street Crossing Site #L-51

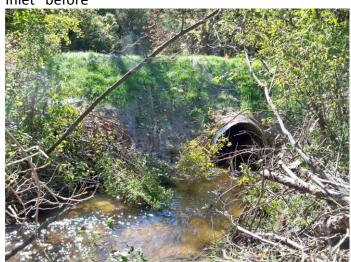
Inlet "before"

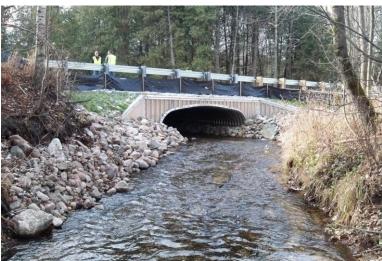
Inlet "after"

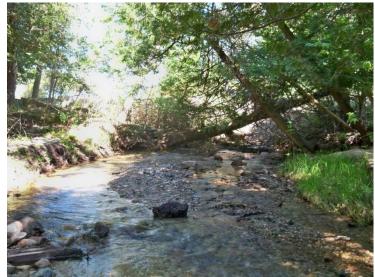
Outlet "before"

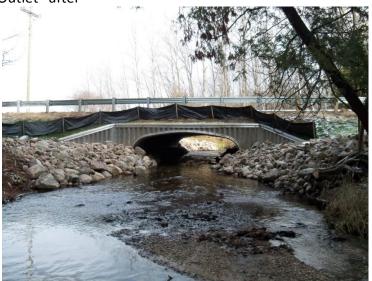
Outlet "after"

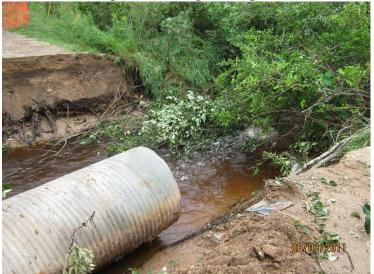
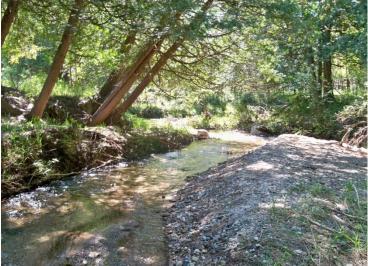
In August of 2011, the road crossing #L-51 where Baker Creek crosses 56<sup>th</sup> Street a second time completely failed. A high water event during which the area received 6 inches of rain in a 12 hour period, combined with woody debris getting lodged in the site's 36" diameter culvert caused the road crossing to wash out. Lake County Road Commission estimated that 150 cubic yards of material washed into Baker Creek and the Middle Branch from the failure event. Prior to the wash-out, the culvert at 56<sup>th</sup> Street was undersized and perched thus blocking the movement of most aquatic organisms between Baker Creek and the Middle Branch.

The road crossing failed during the August 2011 flood event & deposited sediment & gravel downstream.

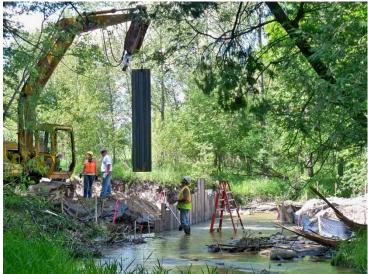
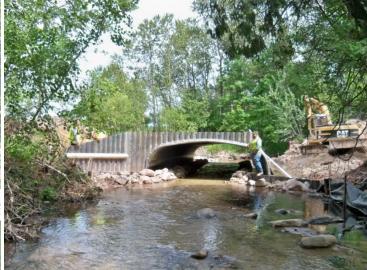
During construction of the new bottomless arch structure.

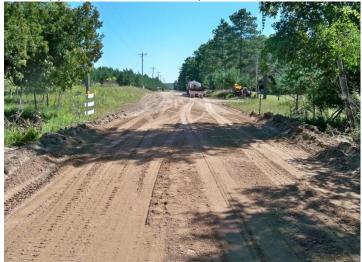
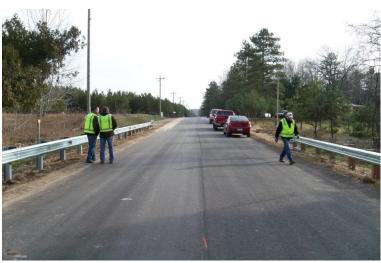
Road approaches continuously washed into the stream. Paving helps route runoff away from the stream.

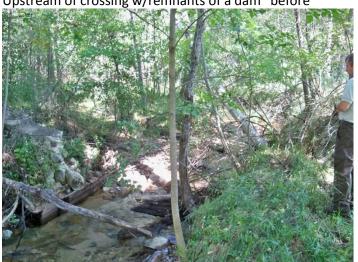
Upstream of crossing w/remnants of a dam "before"

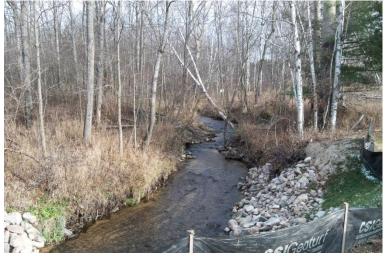
Upstream of crossing "after"
