## Conservation Resource Alliance

# Sanborn Creek 40th St. Restoration Project Pere Marquette River Watershed

October 2013 to October 2014

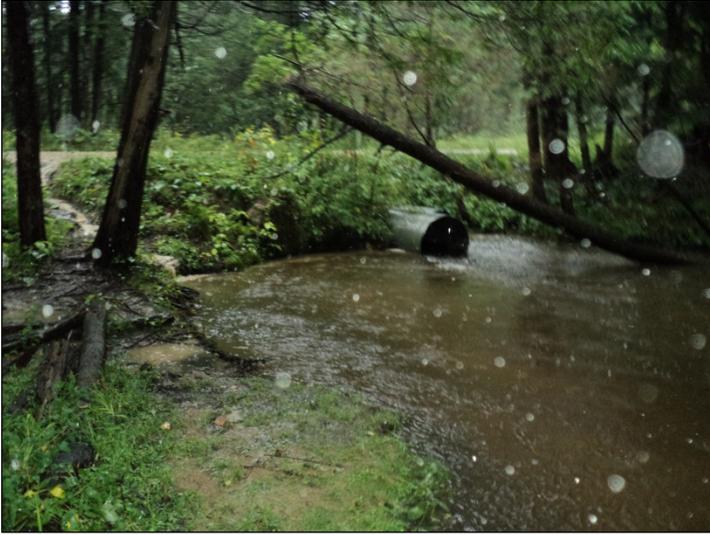
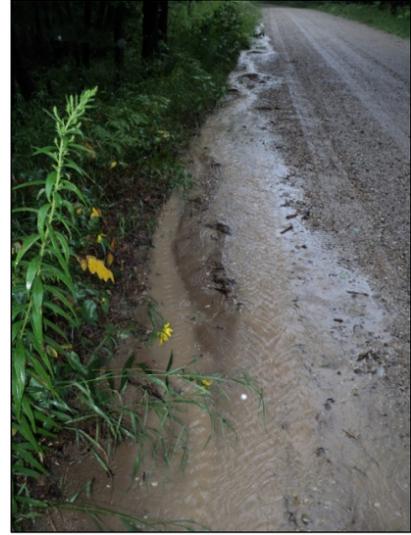
Site #L-65 Before – undersized culverts and road runoff during rain events and snow melt were problematic

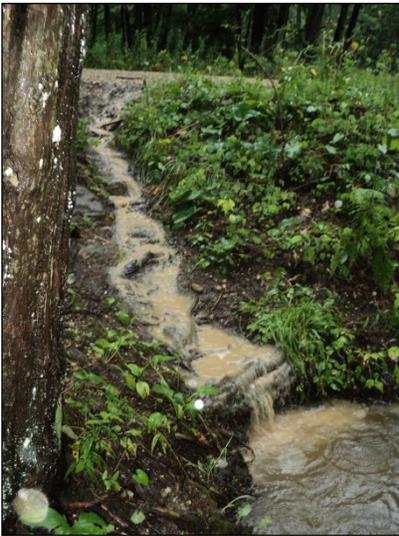
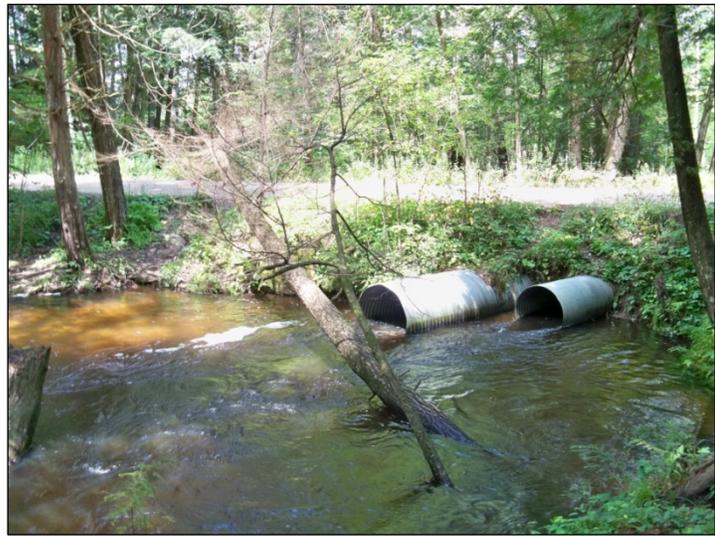
Site #L-65 Before – culverts were awkwardly skewed and runoff drained directly into Sanborn Creek

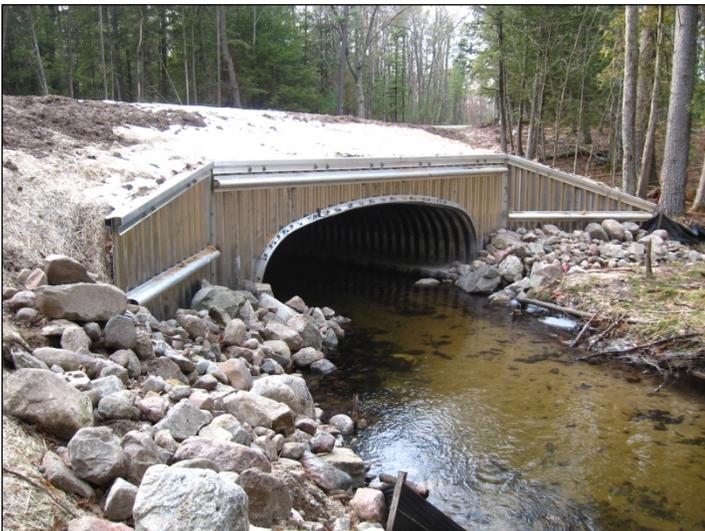
Site #L-65 After – a 16' wide bottomless arch effectively spans Sanborn Creek & allows for a natural stream bottom

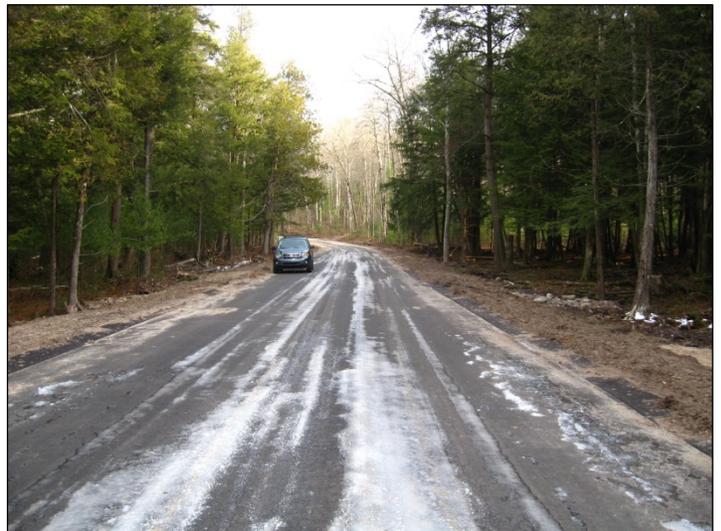
Site #L-65 After – paved approaches, curbing and spillways route runoff into nearby upland areas

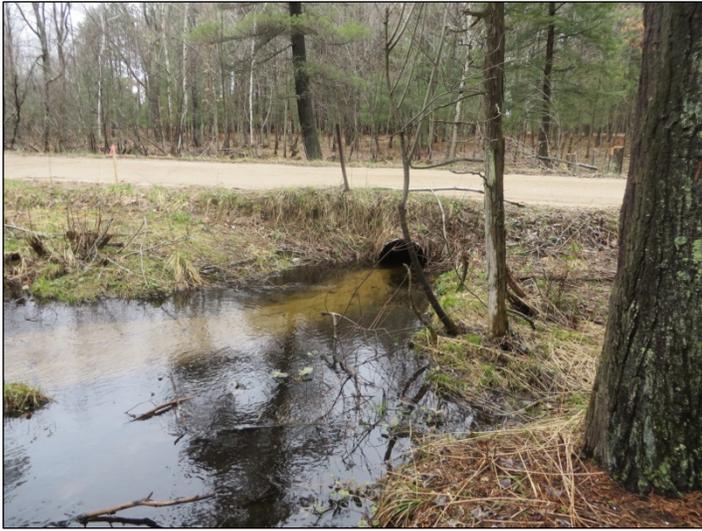
Site #L-67 Before – 2' dia. culvert caused pool formation at the inlet & impounded sediment on this Sanborn tributary

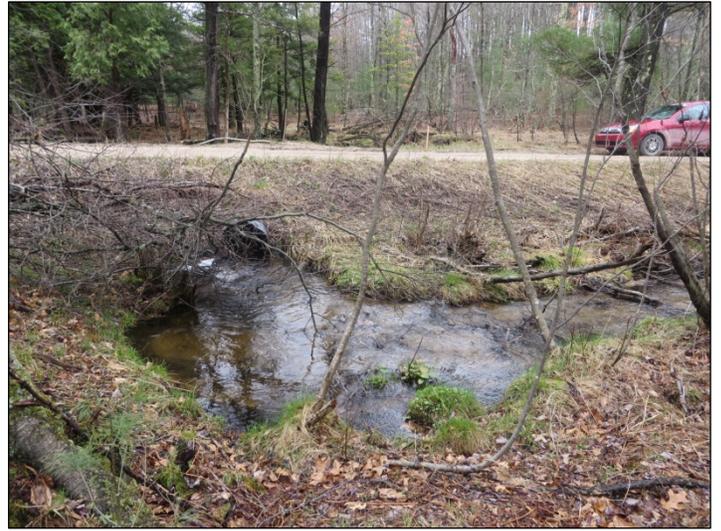
Site #L-67 Before – at the outlet the stream then flowed alongside the road for several hundred feet

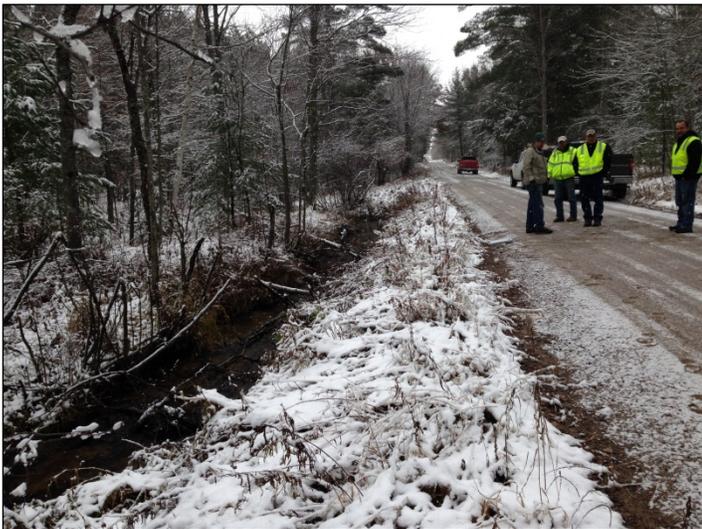
Site #L-67 Before – the stream flowed alongside the road collecting road runoff & sediment from the shoulders

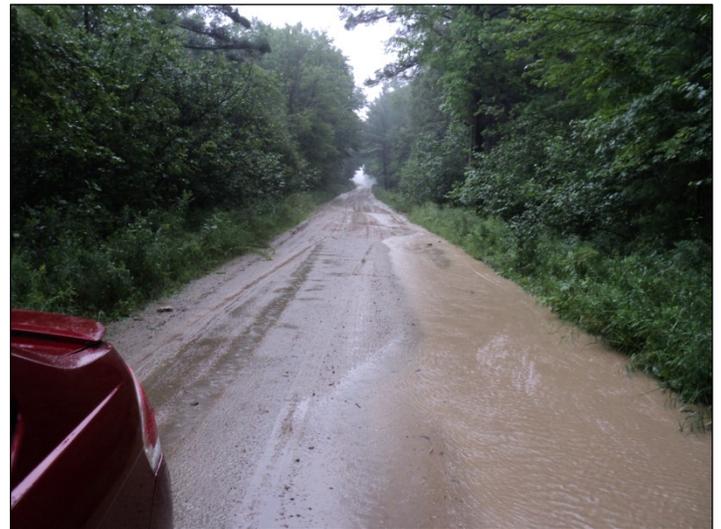
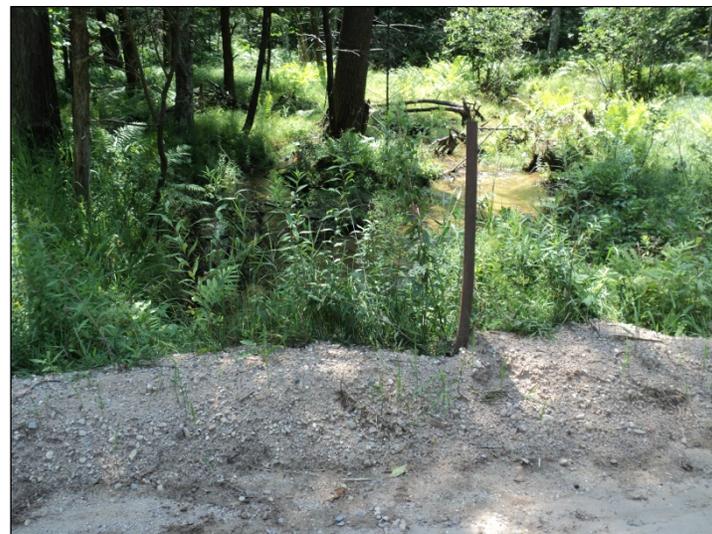
Site #L-67 Before – Road grading contributed excessive sediment to this stream

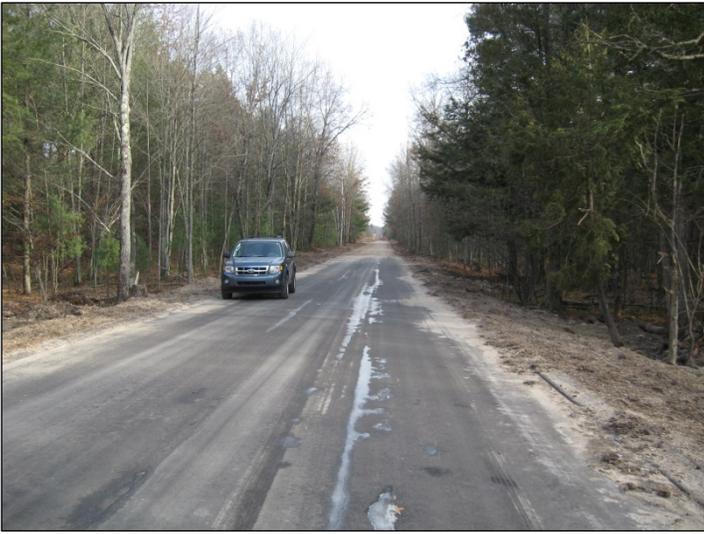
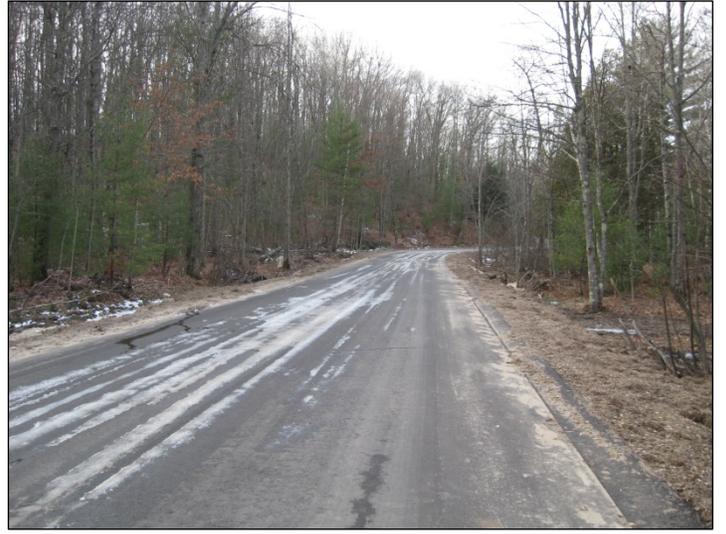
Site #L-67 After – Paved approaches and spillways divert runoff away from the stream & stop erosion of the roadbed

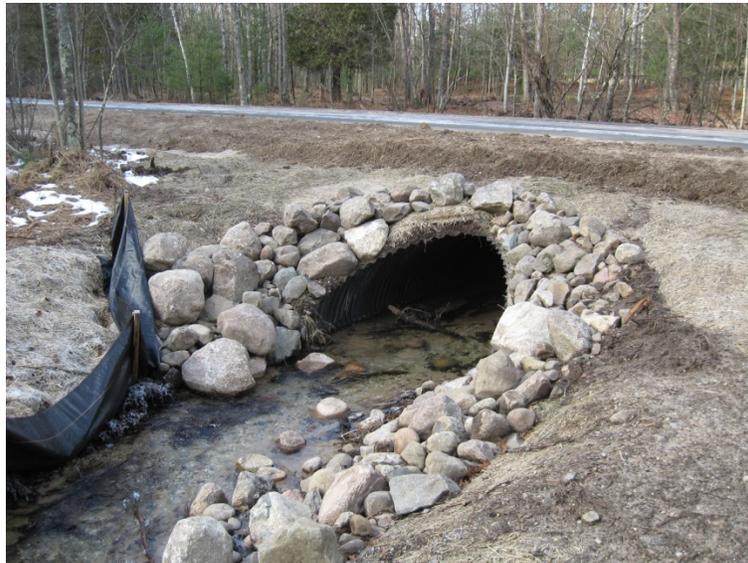
Site #L-67 After – The Sanborn tributary now flows through a 6' diameter, 60' long poly-coated CMP

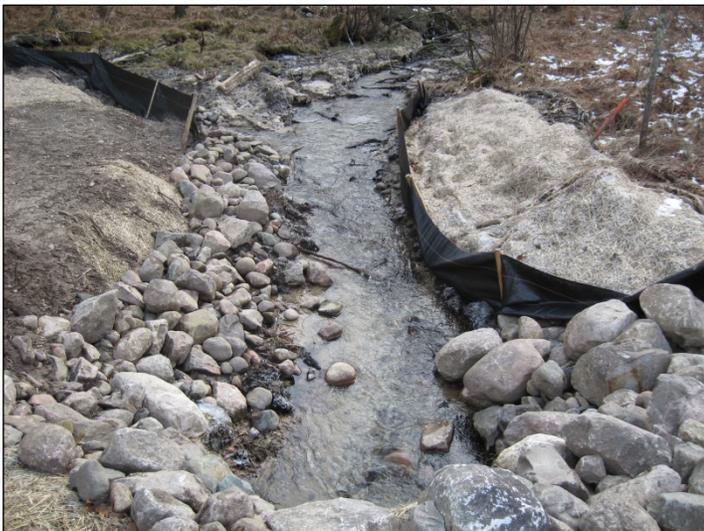
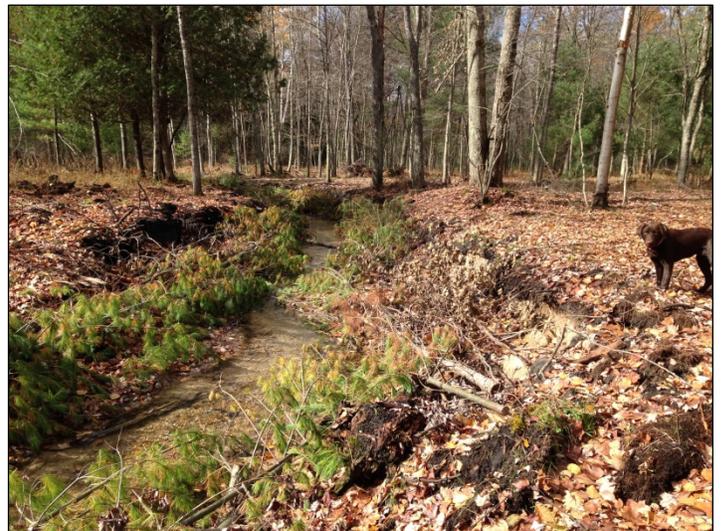
Site #L-67 After – Fieldstone was placed at the culvert and woody debris was placed along the stream downstream
