# Sanborn Creek & King Road Improvement Project Pere Marquette River Watershed May-October 2011

## King Road and Sanborn Creek Site #L-82 Photos

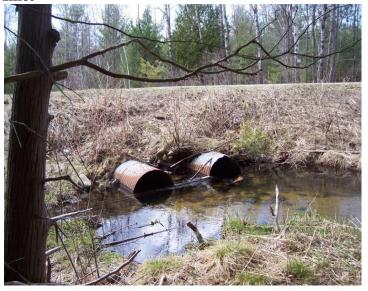
*Before* Inlet

The King road/stream crossing, site #L-82, was comprised of twin 30" diameter culverts that were significantly undersized for the stream. Through this project partners designed and completed the installation of a bottomless arch culvert that accommodates the natural stream channel and allows the natural movement of substrate, fish and wildlife. Paved approaches and spillways channel road runoff away from the stream as well.

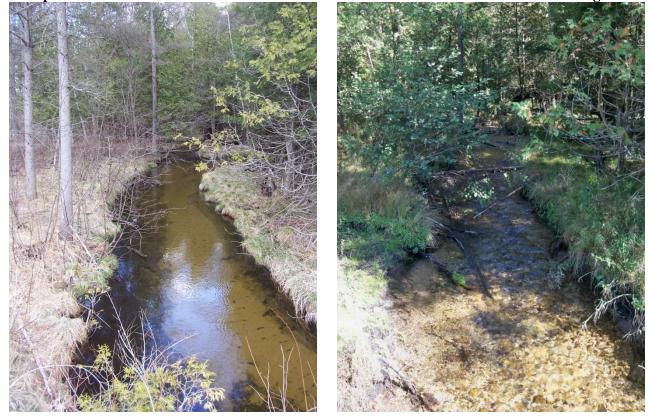
#### Upstream

Before – impounded sediment due to undersized culverts. After – sediment movement uncovered a gravel bottom.
