Baker Road & Middle Branch Timber Bridge Project Pere Marquette River Watershed

October 2009

Baker Road Middle Branch Timber Bridge Photos – Site #L-45

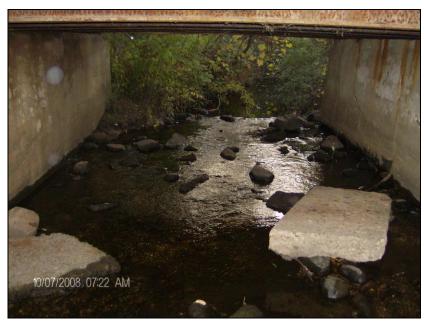
Baker Road Bridge, site #L-45, was an old bridge on the Middle Branch that failed and was closed in 2008. Large pieces of concrete from the bridge decking had fallen into the stream and the support beams were rusting through. The failure of this bridge prohibited fish passage. Through this project partners designed and completed the bridge deck replacement and approach work including grading, paving and curbing 950 lineal feet of steep roadway in order to channel runoff away from the stream.

Bridge deck – before

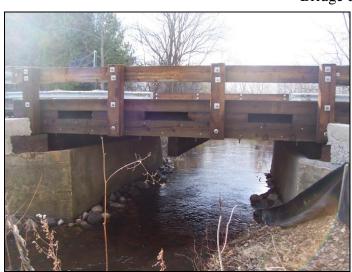
Bridge deck – after

- Timber deck installation incl. support beams & guardrail
- Fieldstone placement
- Pave & curb approaches (950 lineal feet)
- 4 diversion outlets
- Grading and revegetation
- Removal of broken structure instream

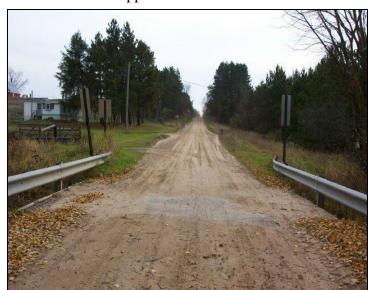
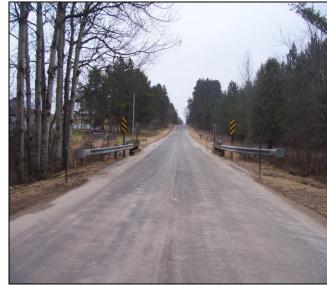
Approaches - after
