Sanborn Creek & Nelson Road Improvement Project Pere Marquette River Watershed

May – October 2011

Nelson Road and Sanborn Creek Site #L-60 Photos

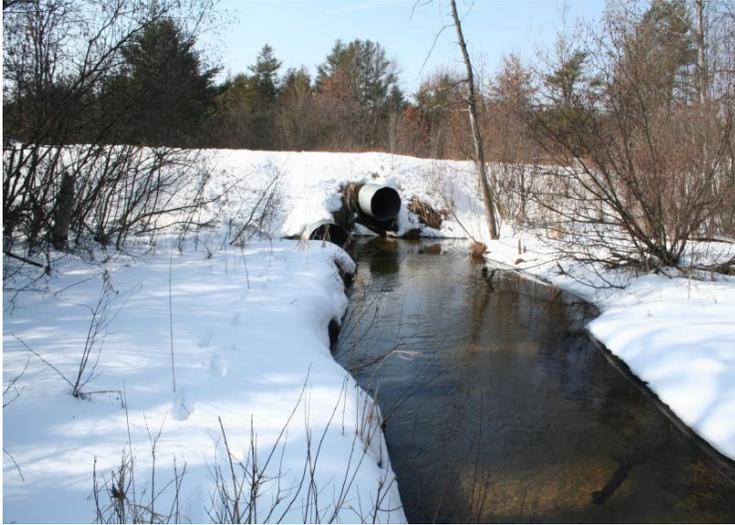
Before
Inlet

The Nelson road/stream crossing, site #L-60, was comprised of 48” and 36” diameter culverts that were significantly undersized for the stream. Through this project partners designed and completed the installation of a bottomless arch culvert that accommodates the natural stream channel and allows the natural movement of substrate, fish and wildlife. Paved approaches and spillways channel road runoff away from the stream as well.

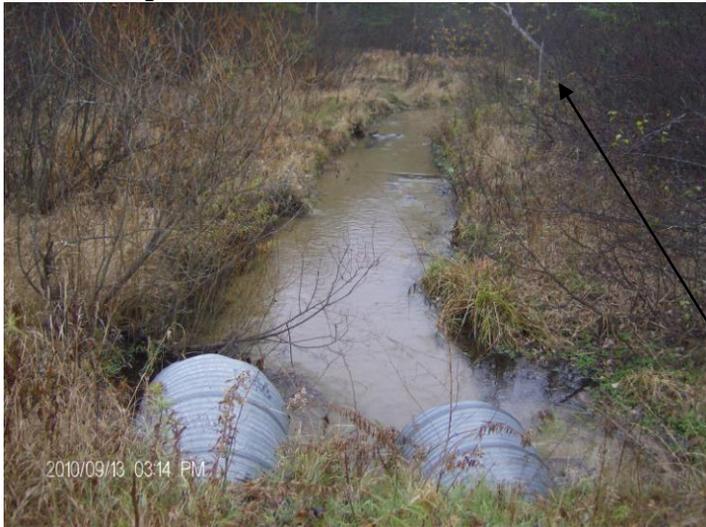
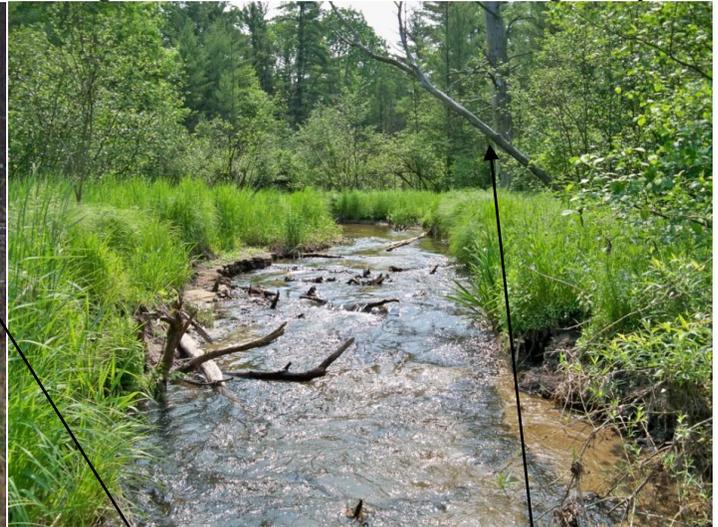
Upstream

Before – impounded sediment due to undersized culverts. During – sediment movement is uncovering woody debris.

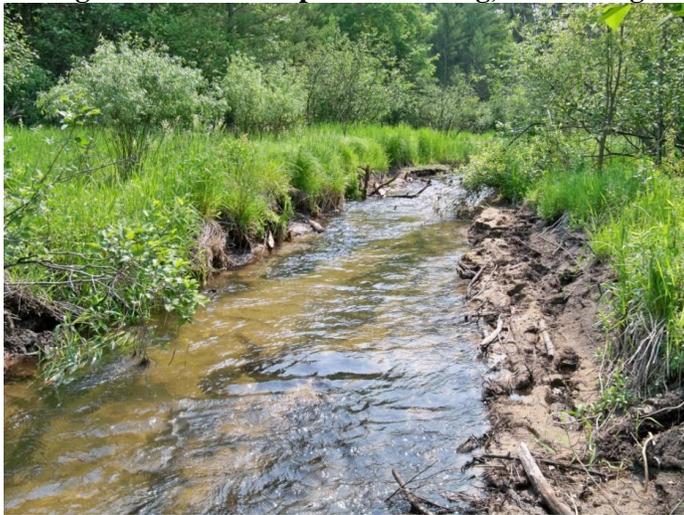
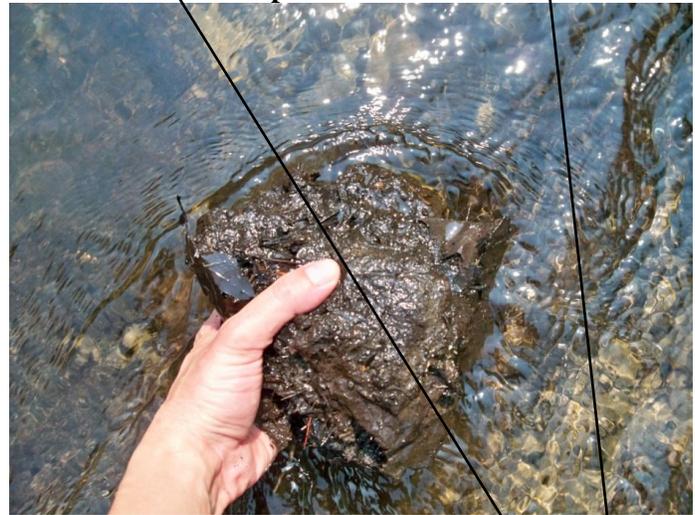
During – stream bed slope is increasing, uncovering detritus & muck from impounded channel.

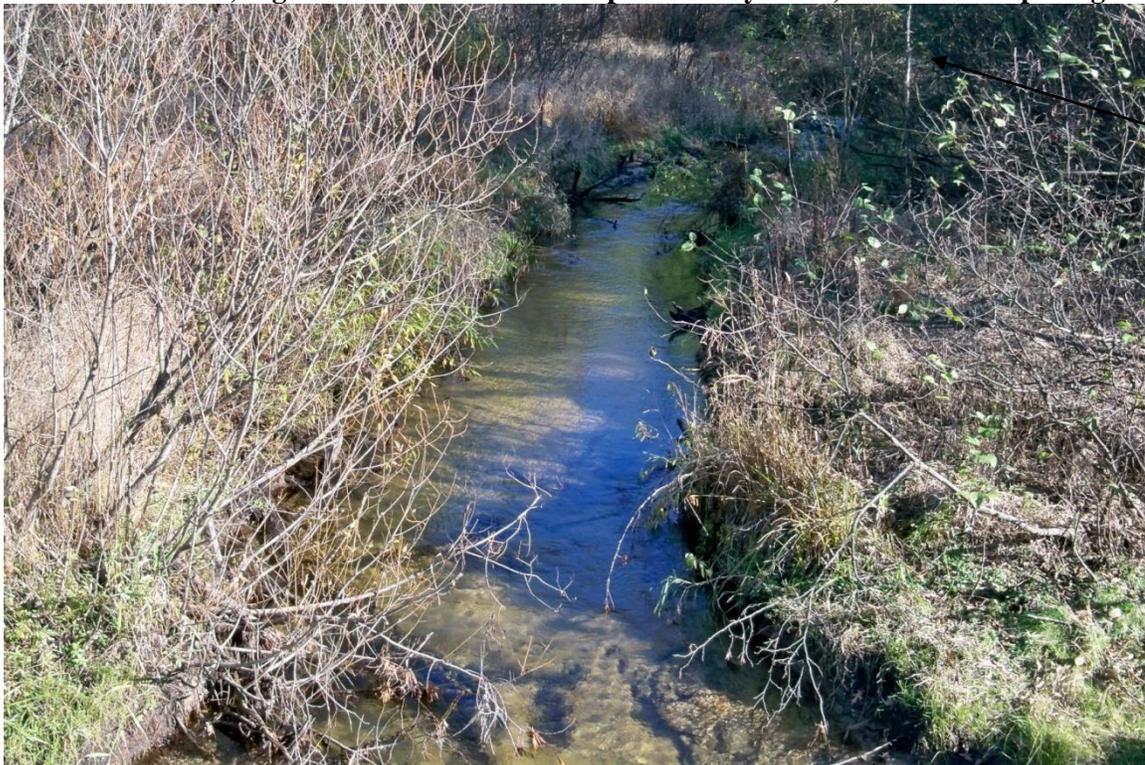
After construction, vegetation has encroached exposed sandy areas, channel is deepening and gradient is increasing.

Note leaning snag.
