Betsie River Bridge Abutment Removal & Restoration Project

November 2015

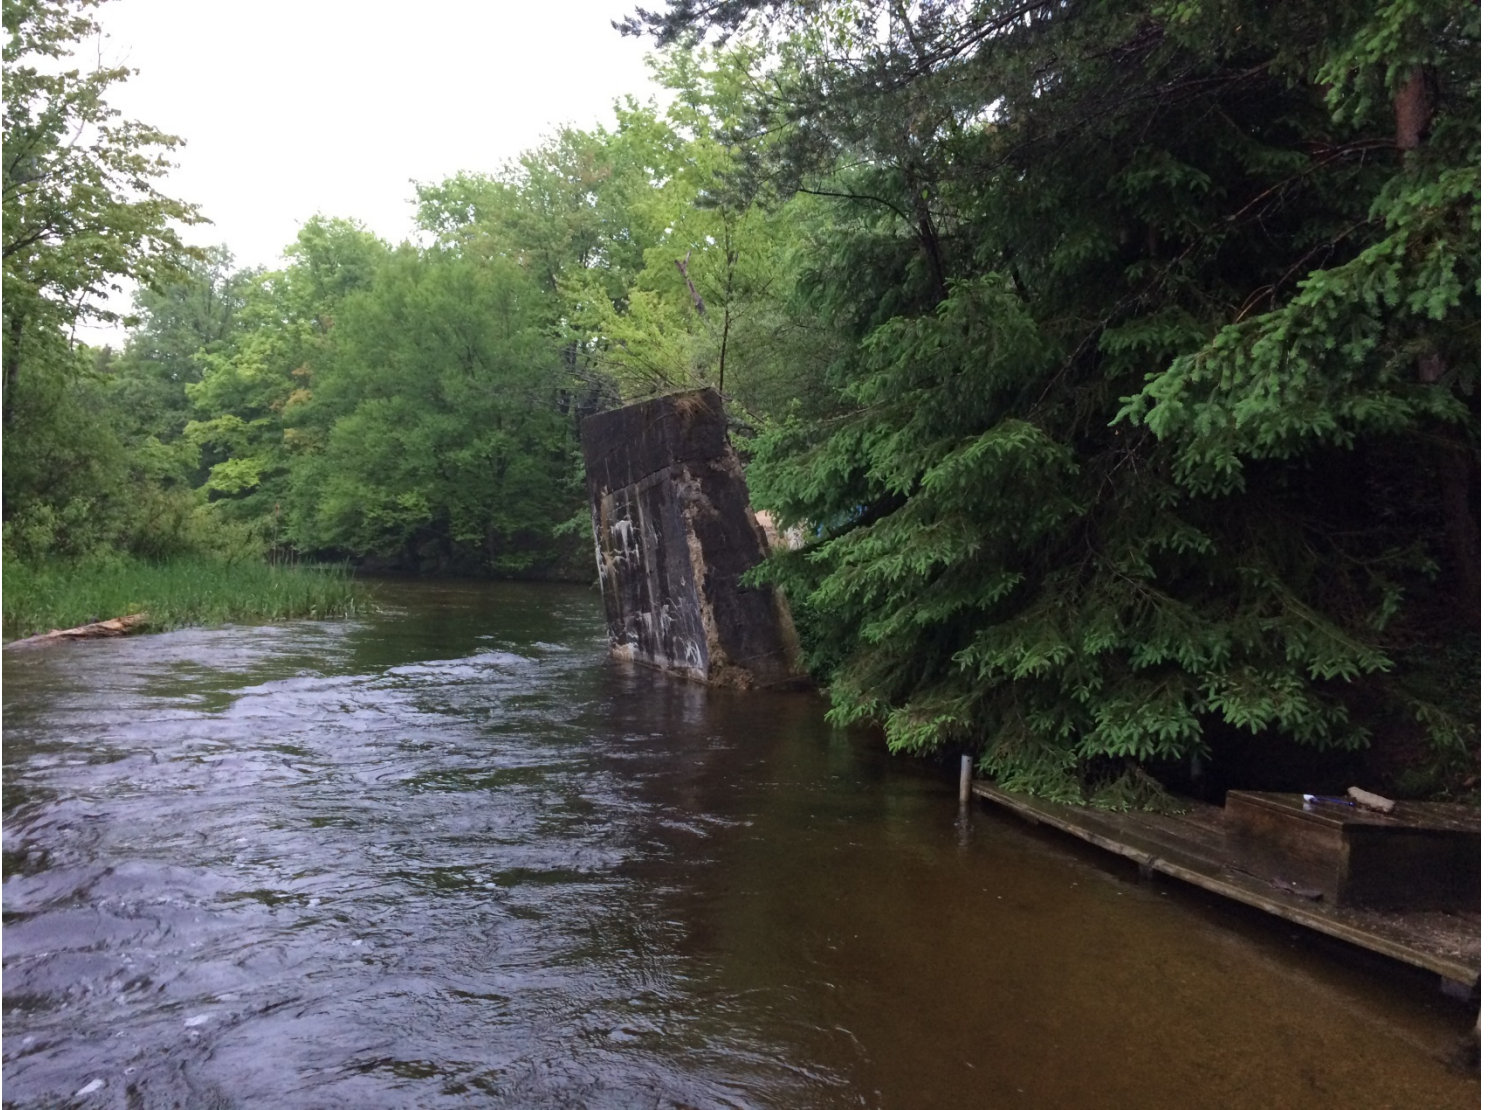
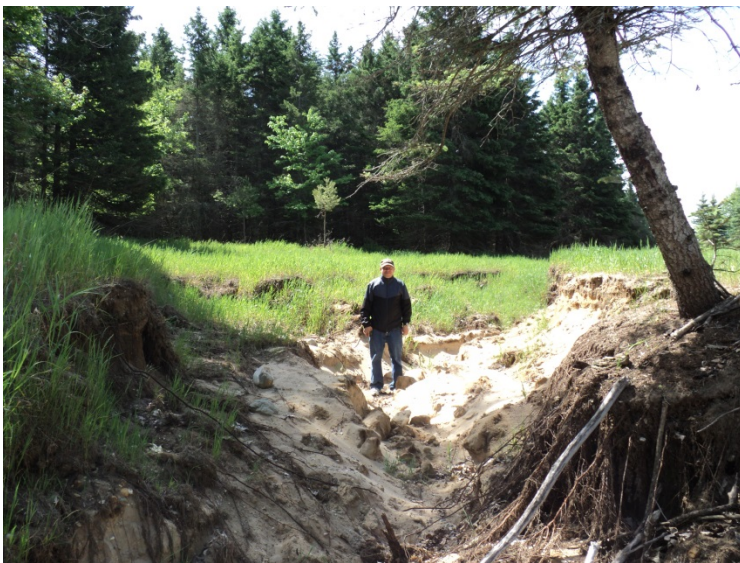
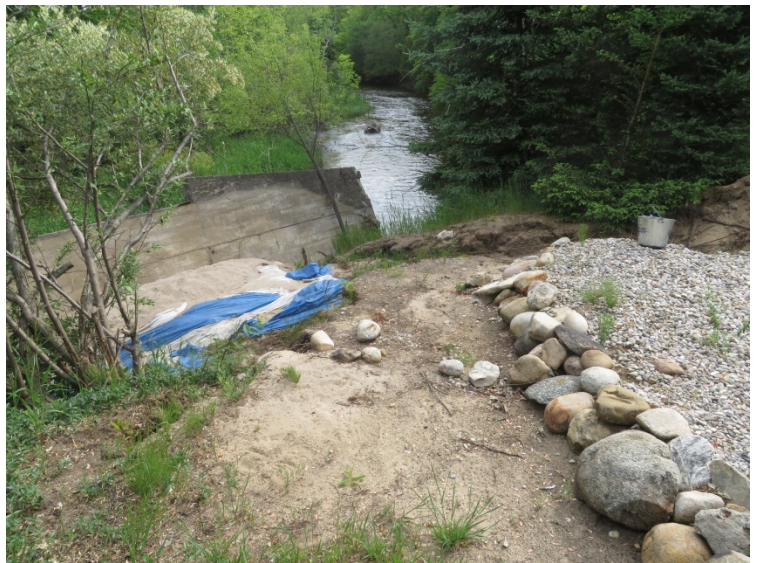
Before – Abandoned bridge abutment was leaning into the river & the erosion behind it was severe.

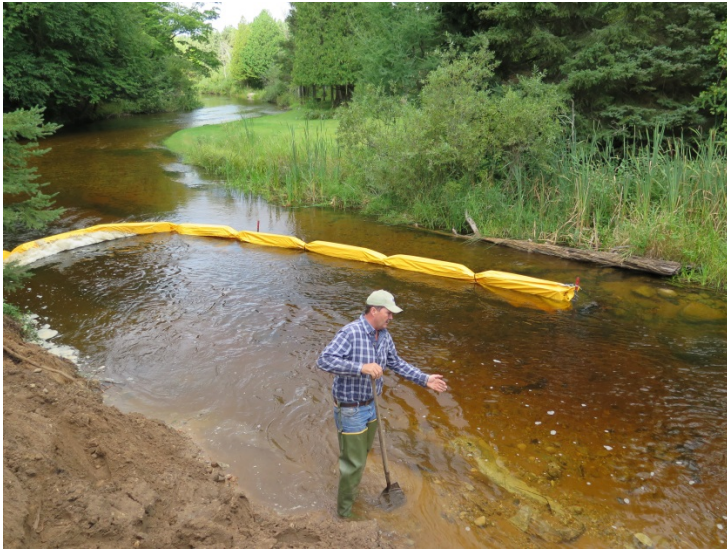
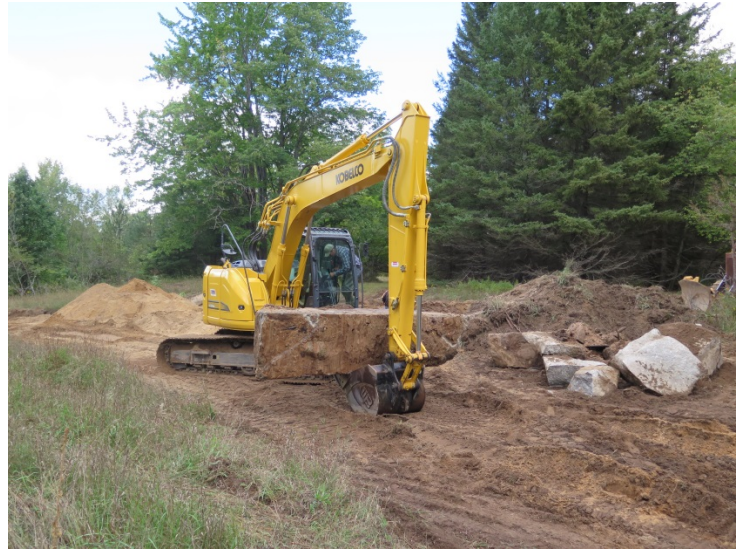
During – Concrete was removed, broken and buried on site. Area was re-graded, stabilized & planted.

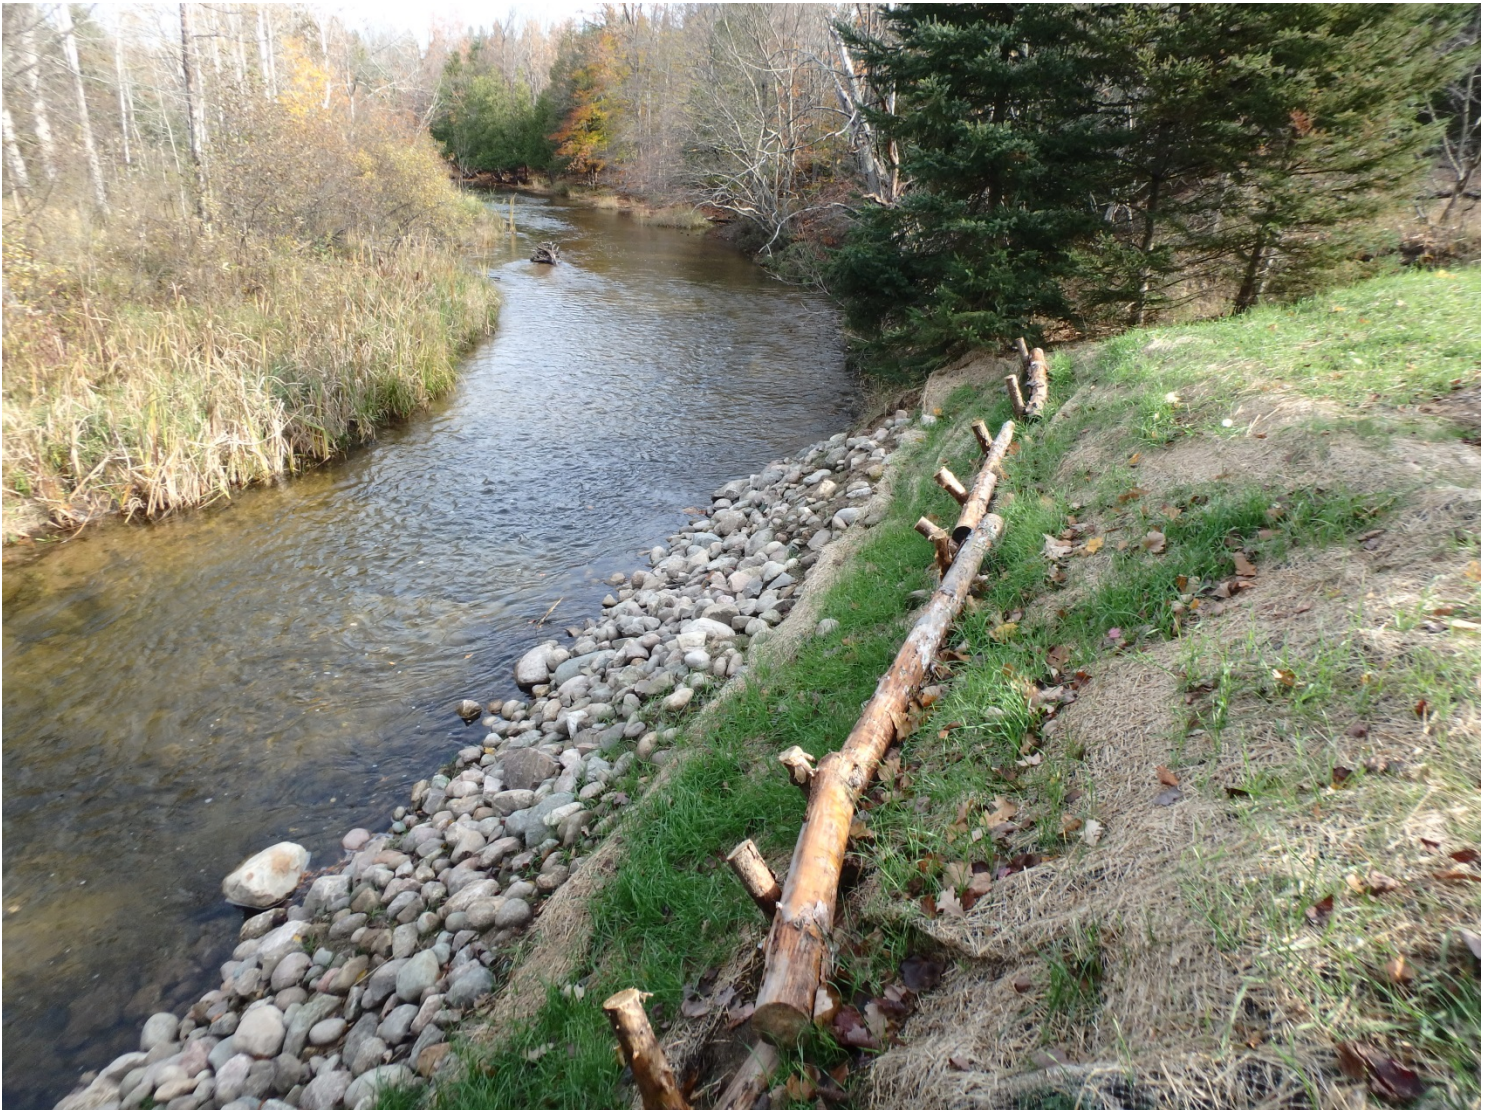
After – Streambank was pulled back, resloped and stabilized.

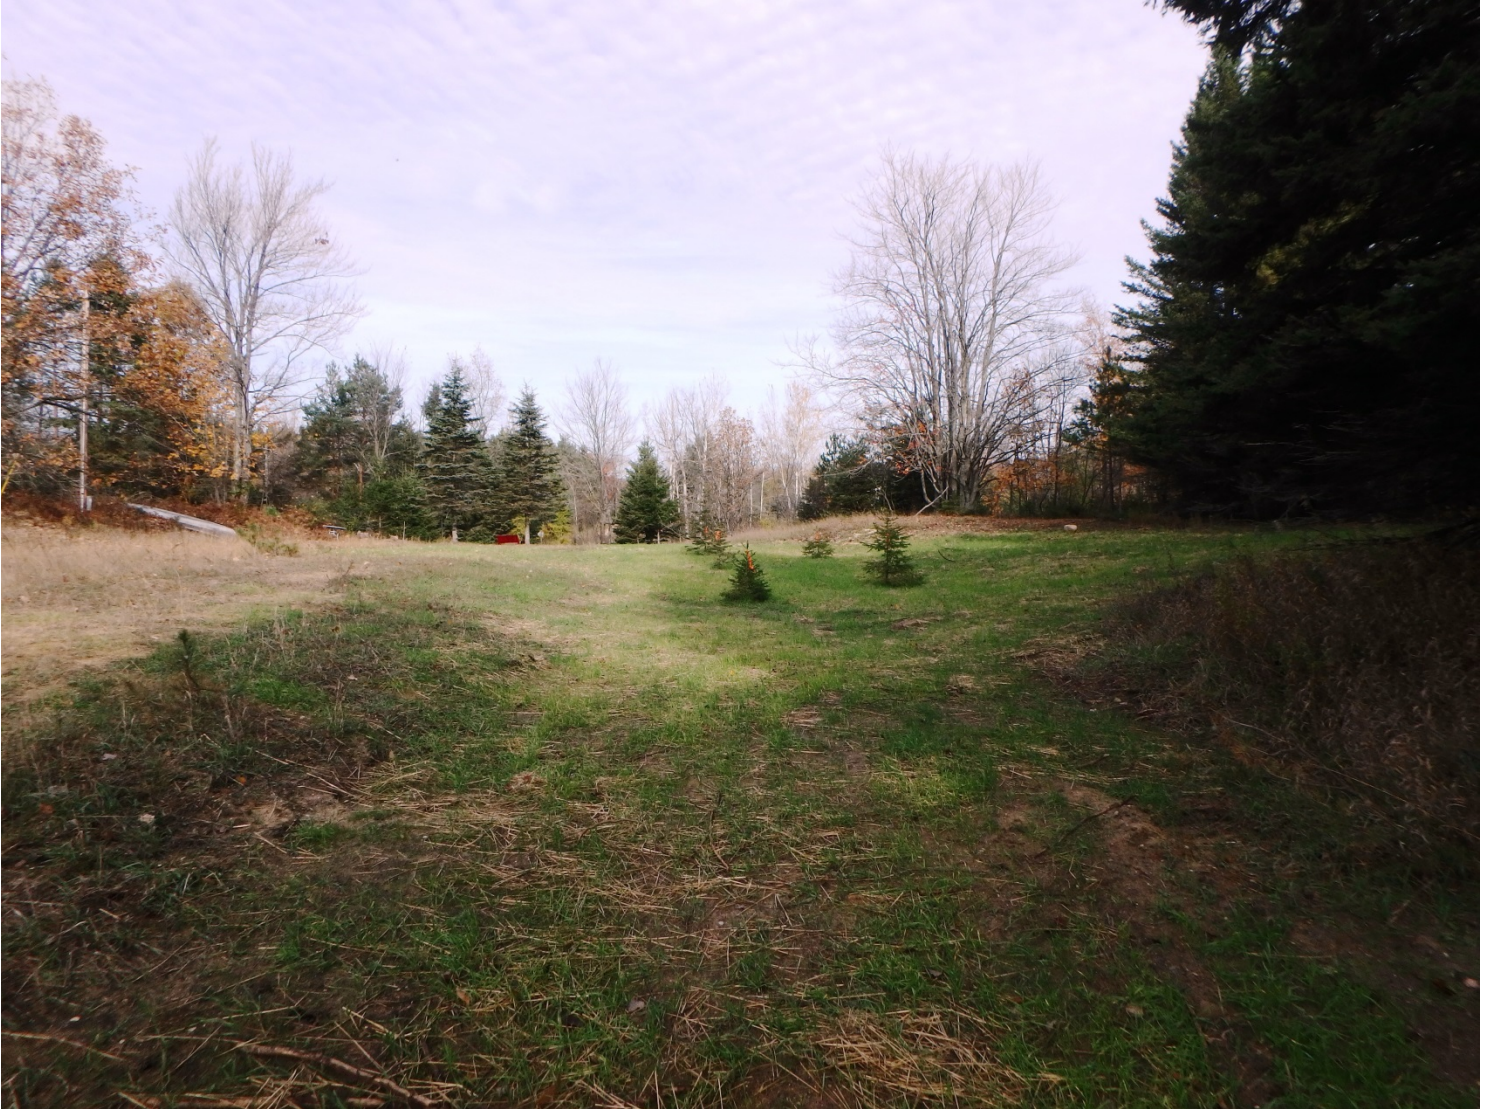
After – Adjacent upland area was graded, seeded and planted with transplanted spruces.

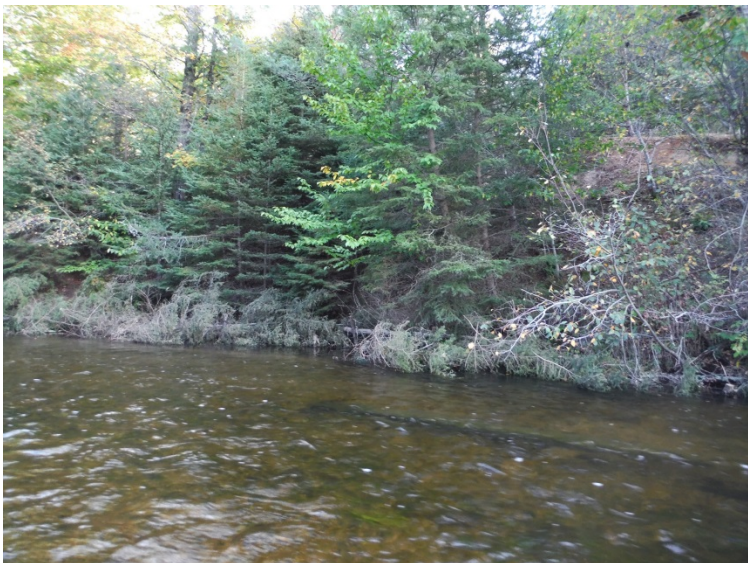
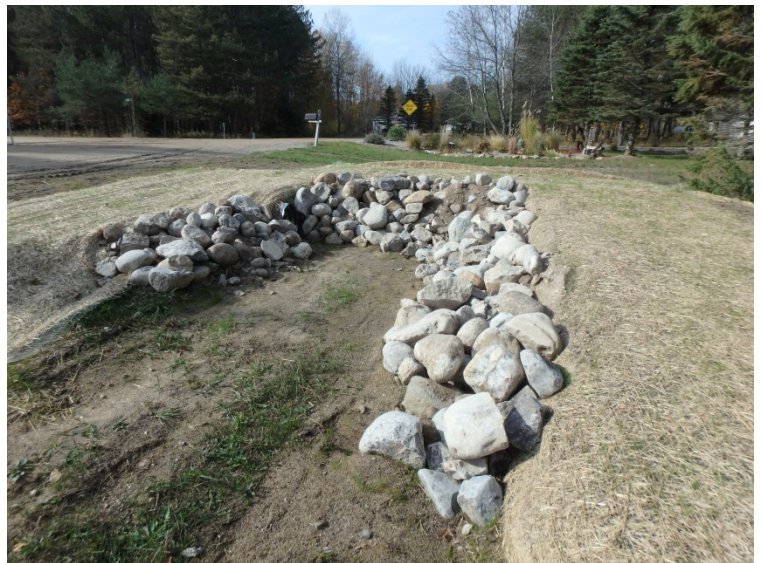
After – Woody debris was secured along the toe immediately upstream of the restoration work & nearby road drainage culverts were upgraded.
