# Betsie River & King Road Improvement Project

December 2010

Conservation  
Resource Alliance

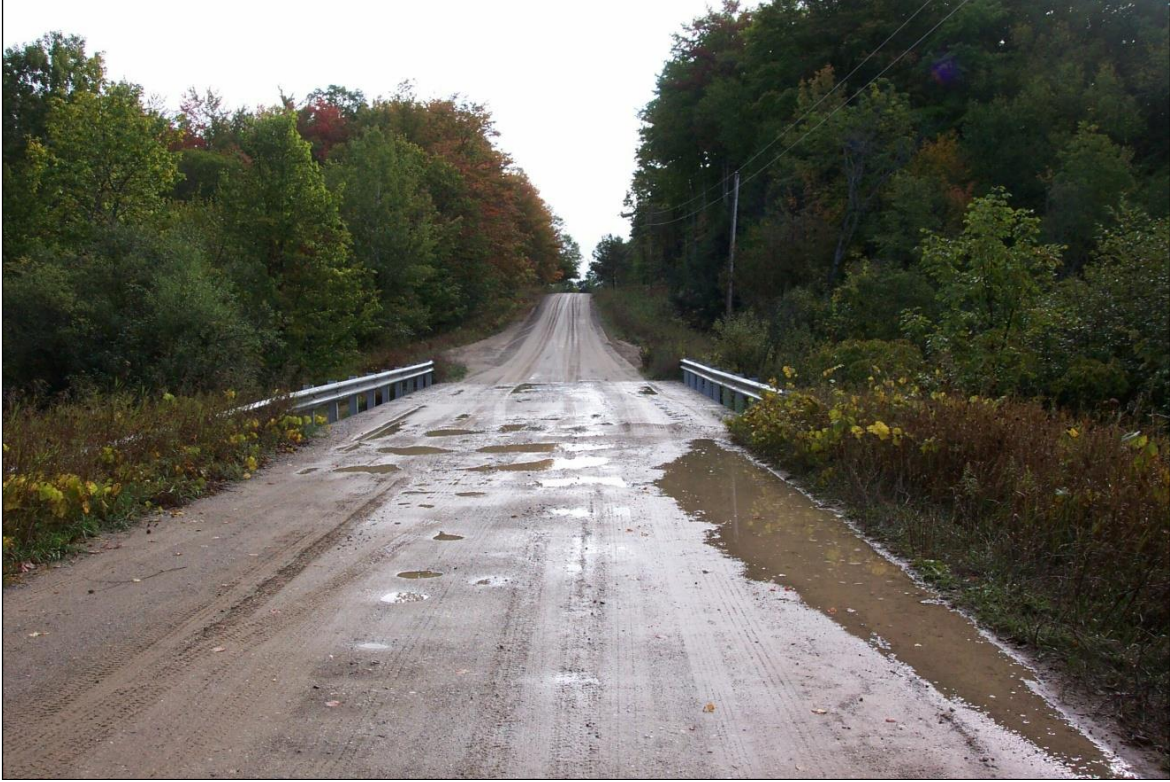
“Before”

The Betsie River is a State Designated Natural River and is well known for its steelhead and salmon fishery. The Betsie River is a Lake Michigan tributary and it flows through Grand Traverse, Benzie, and Manistee Counties, with its headwaters starting in Green Lake. The Betsie River Watershed has 106 road/stream crossings with 64 recommended for some type of improvement. Site #B-20 is where the Betsie mainstem crosses King Road; this site was ranked severe with its steep, sandy eroding road approaches that washed over the bridge deck into the river with snowmelt and rain events. By partnering with the Grand Traverse Band, Environmental Protection Agency and the Benzie County Road Commission, sufficient funding was secured in order to harden the approaches and include curbing and diversion outlets to channel runoff away from the stream.

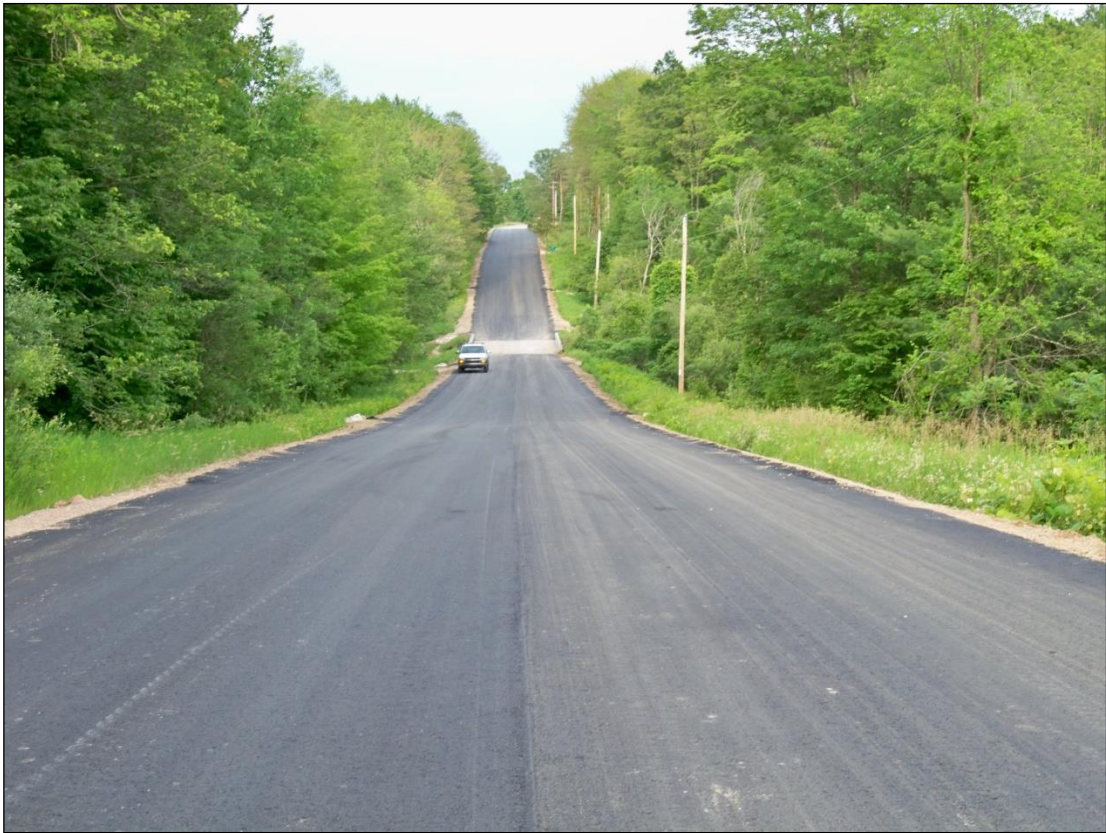
**After best management practices were completed**

- 1,700 feet of pavement
- Curbing
- 6 diversion outlets complete with rock riprap placement
- Guardrail

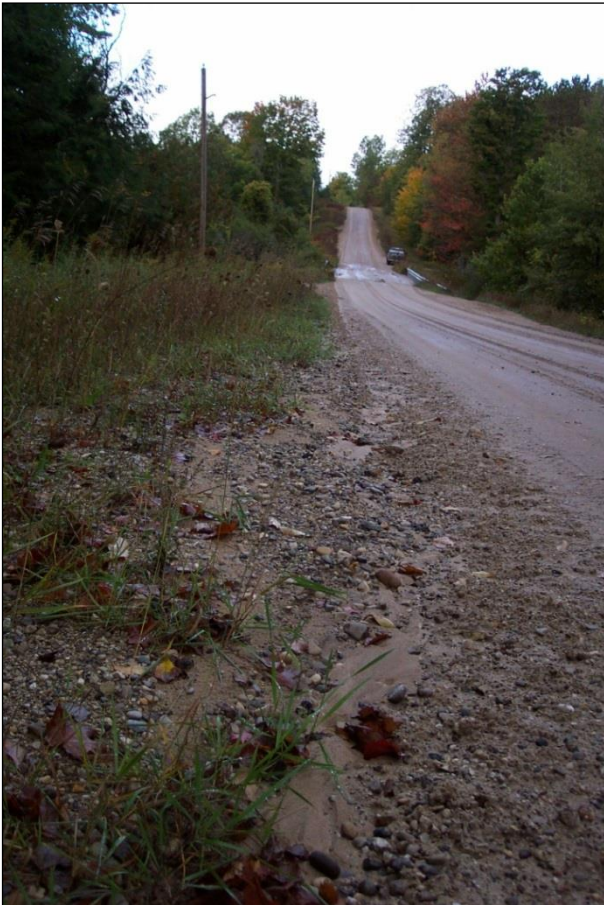
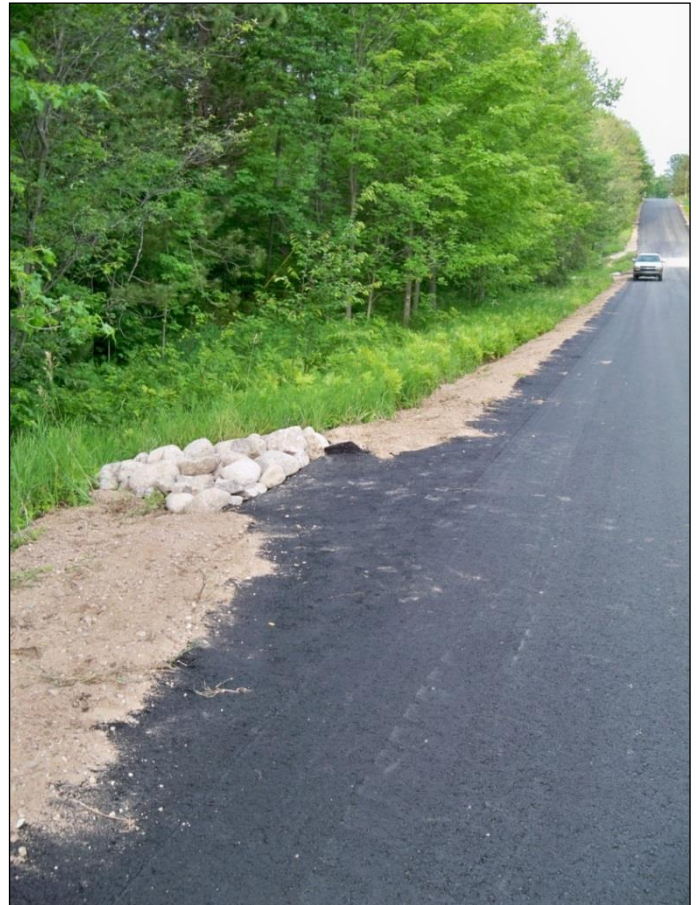
**Curbing and diversion outlets will help channel runoff away from the river and into nearby upland areas**
