Kinney Creek & Wingleton Road Timber Bridge Project Pere Marquette River Watershed

October 2010

Wingleton Road and Kinney Creek Site #L-15 Photos

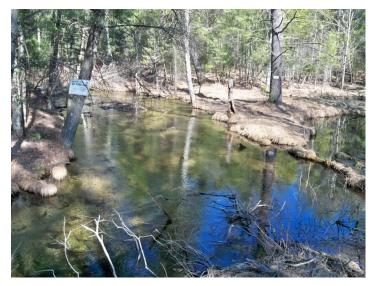
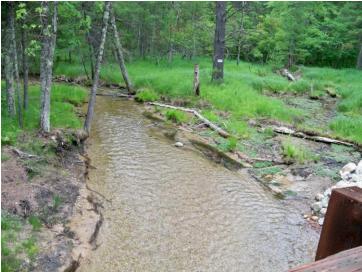
Looking upstream of road crossing – Before

The Wingleton road/stream crossing, site #L-15, was comprised of twin 24" culverts that were undersized and constricting the stream channel. The culverts were approximately 50' long and too short with steep, eroding embankments. Through this project partners designed and completed the installation of a timber bridge that accommodates the natural stream channel. Paved approaches and spillway channel road runoff away from the stream, as well.

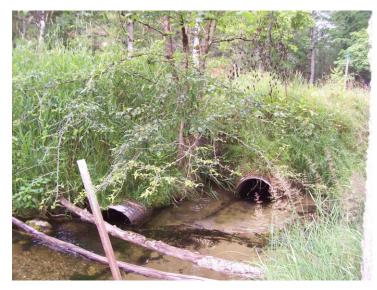
Inlet - Before

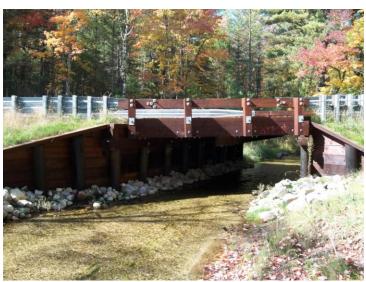
After

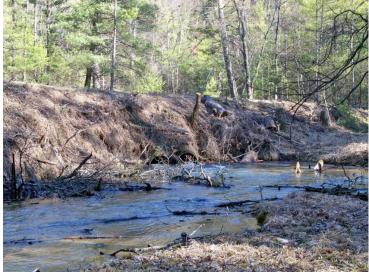
Outlet – Before

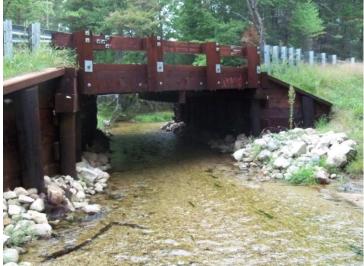
After

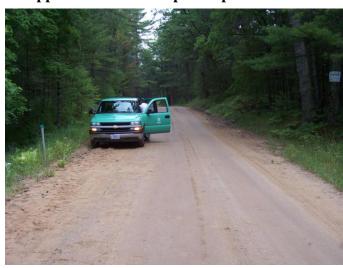
Approaches were steep & unpaved – Before

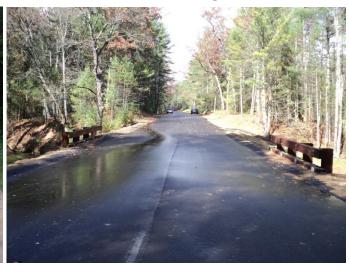
Pavement, curbing – After

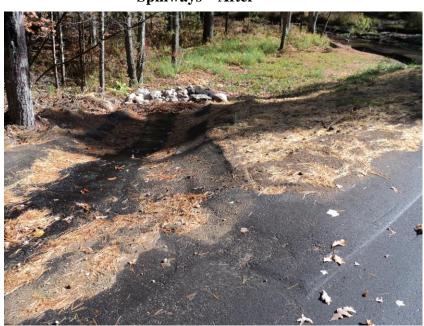
Eroding shoulders – Before

Spillways – After
