Sweetwater Creek & Wingleton Road Timber Bridge Project Pere Marquette River Watershed

Location
Sweetwater Twp.
Section 21
Lake County, MI

Wingleton Road and Sweetwater Creek Site #L-5 Photos

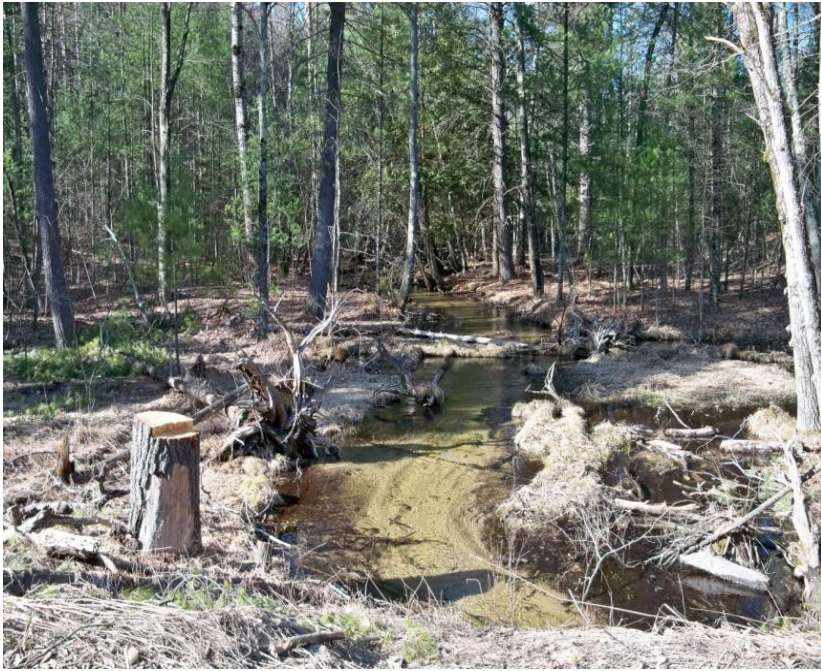
The Wingleton road/stream crossing, site #L-5, was comprised of two 22' undersized culverts, approximately 34' long. Through this project partners designed and completed the installation of a timber bridge that accommodates the natural stream channel. Paved approaches and spillways channel road runoff away from the stream as well.

Looking upstream of road crossing – Before

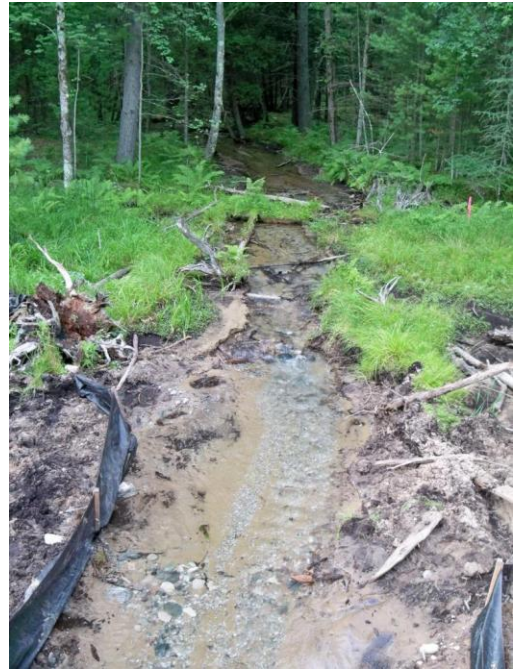
After

- Timber bridge installation (20' span, 30'1" roadway)
- Fieldstone placement
- Pave & curb approaches (1,000 lineal feet)
- 4 spillways
- Grading and revegetation

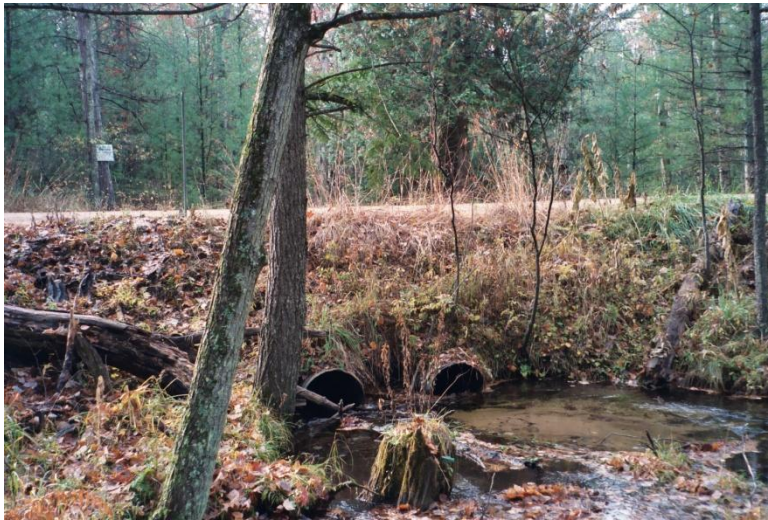
Inlet – Before

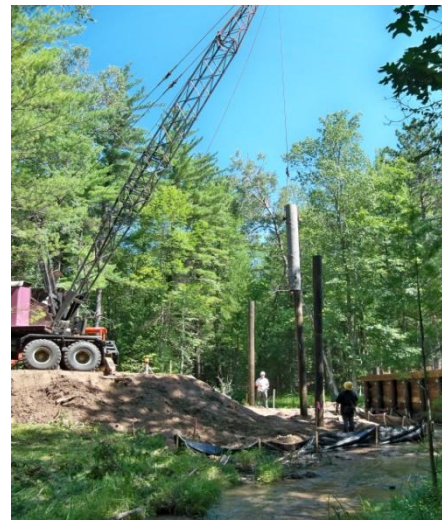
During pile driving

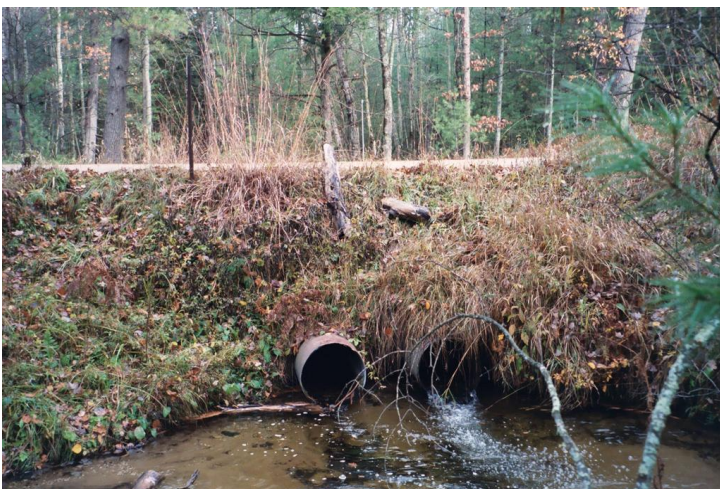
Outlet – Before

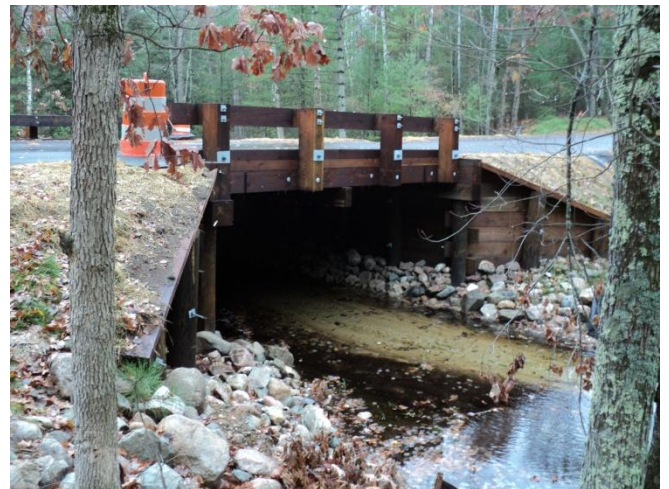
After

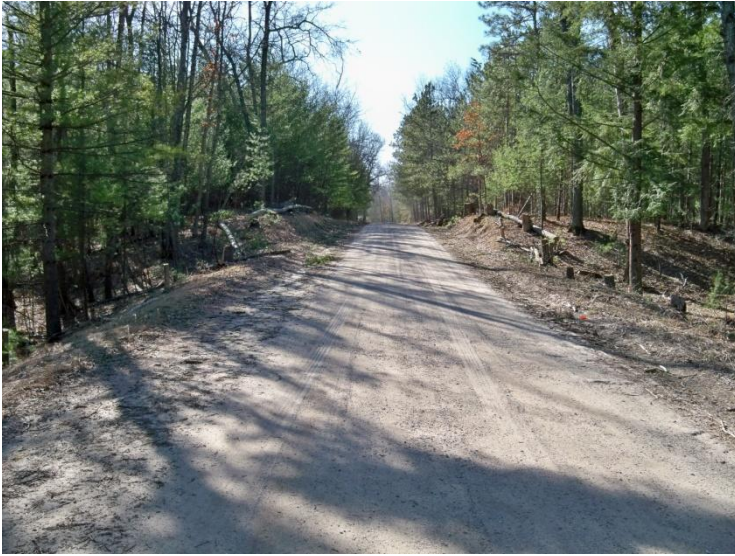
Steep approaches washed into stream – Before

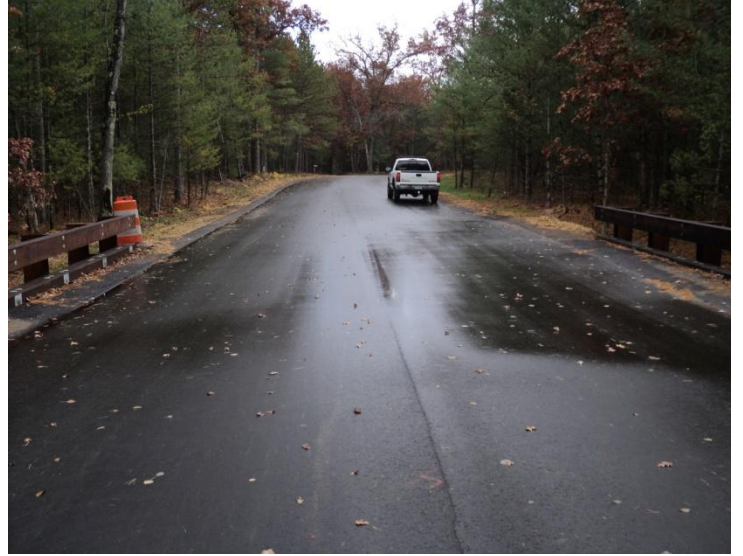
Paved approaches, curbing – After

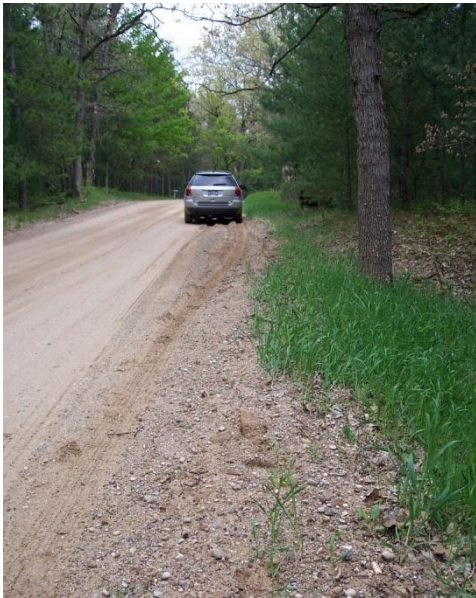
Spillways - After

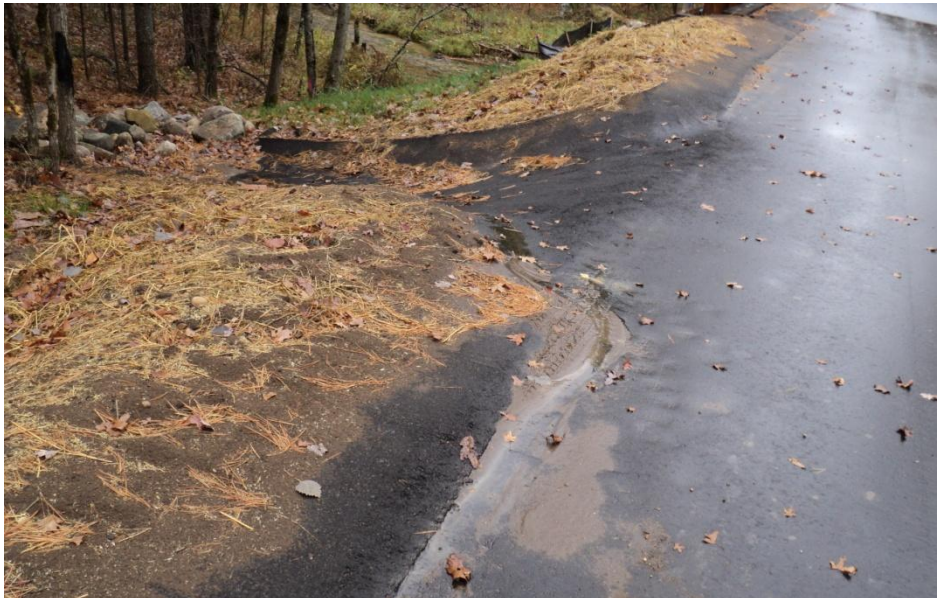
Eroding shoulders – Before
