Conservation Resource Alliance

Red Creek Haze Road Crossing Project 2016

Betsie River – Woody Debris & Bank Stabilization Sites

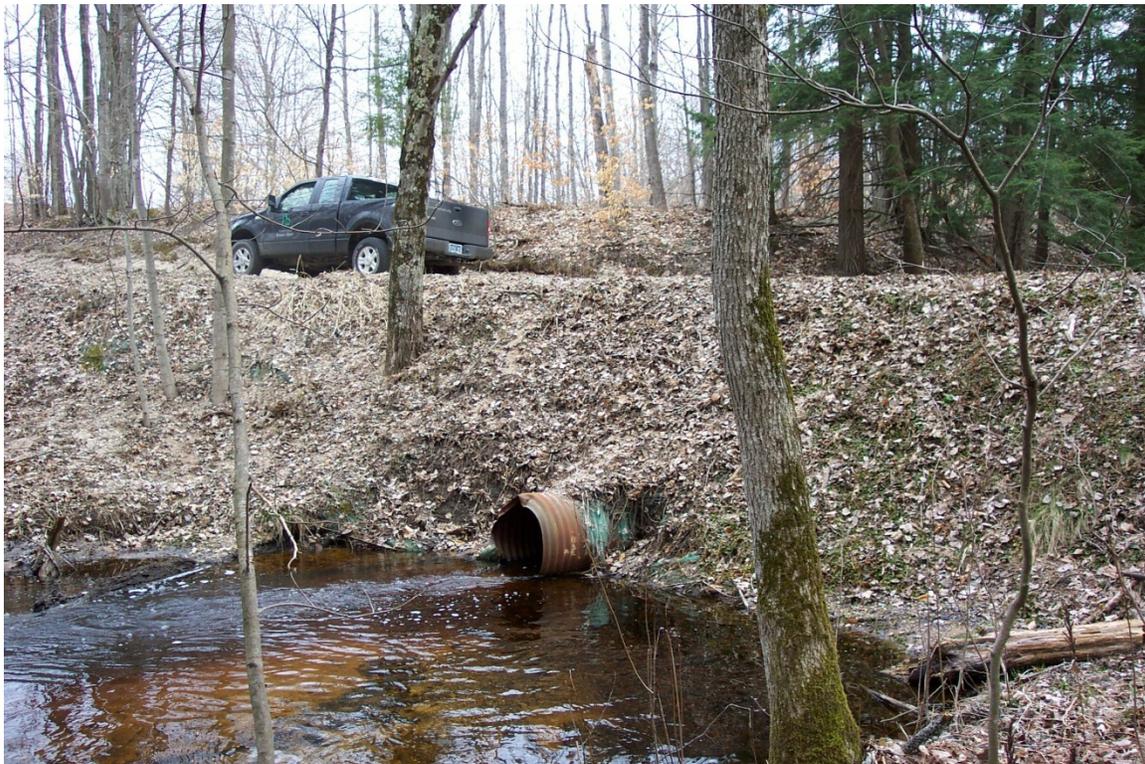
Fieldstone & woody debris were prescribed for the first site, mostly woody debris for the second site along with topsoil, terracing, planting the upper slopes

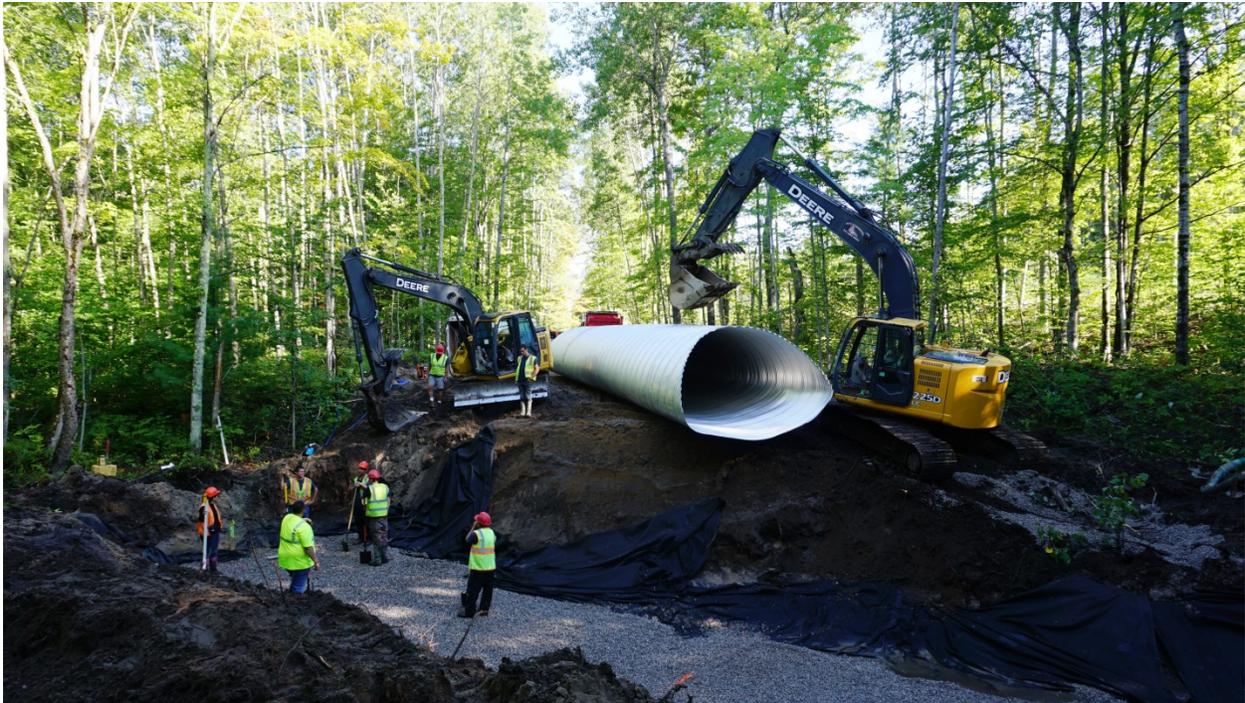
Upper slope work involved log terracing, seeding & some topsoil. Plantings will happen in the spring 2016

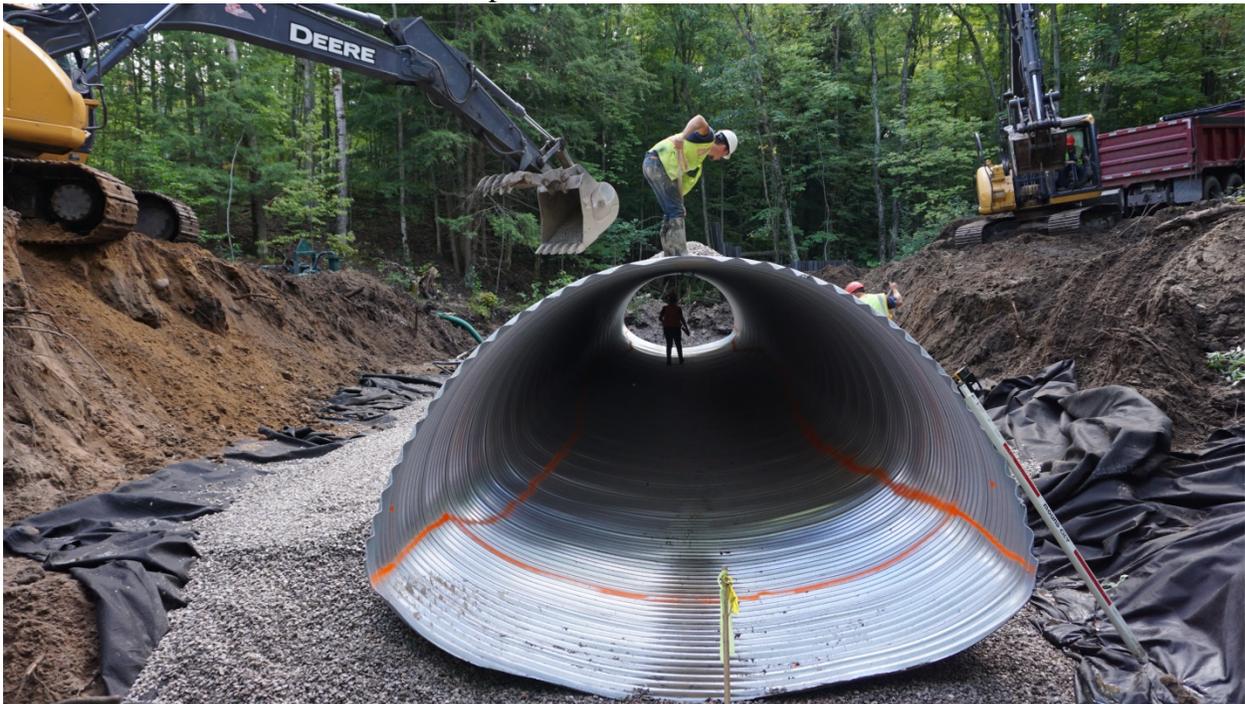
Woody debris using cut red pines from nearby state land was secured with fieldstone placed in & around it at the toe.
