Conservation Resource Alliance

Platte River & Burnt Mill Bridge

October 2009 through August 2010

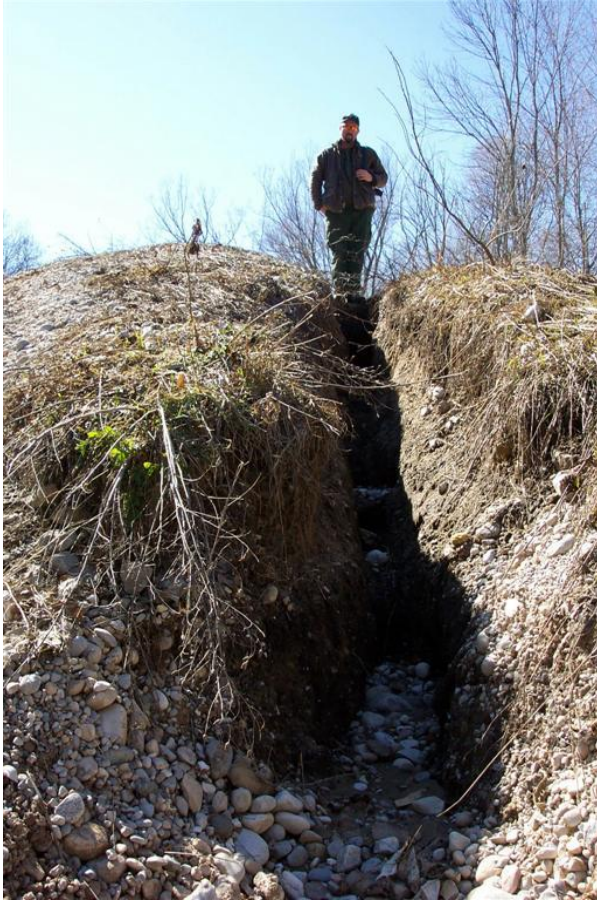
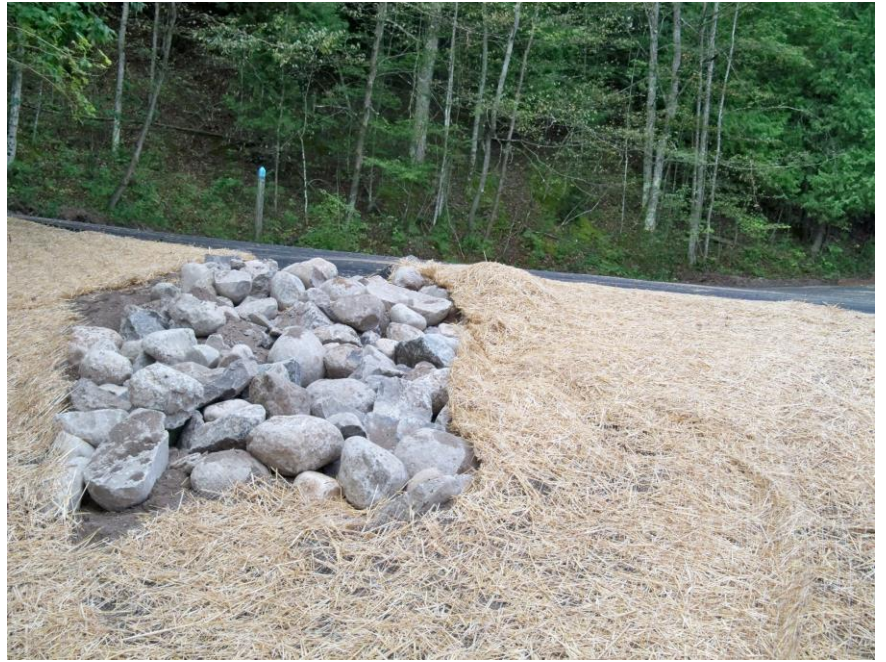
“Before” – runoff caused washouts along the road shoulders... “after” – spillways will help control & direct runoff.

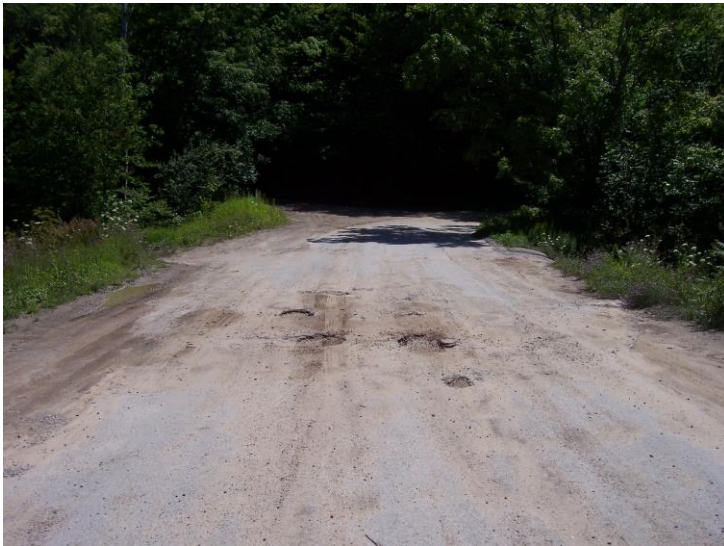
“Before” – the roadbed was in poor shape...

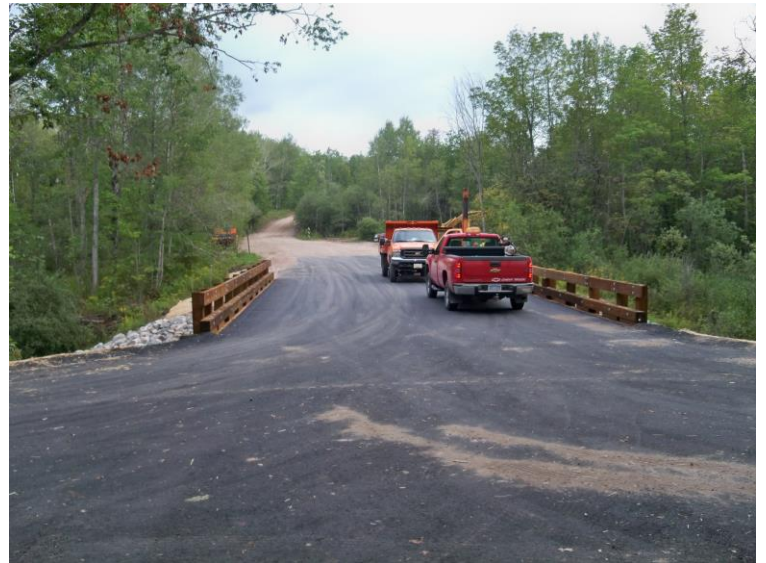
“after” – pavement will help direct runoff & prevent roadbed erosion.
