**North Branch Manistee River and Mecum Road Crossing
Kalkaska County, MI**

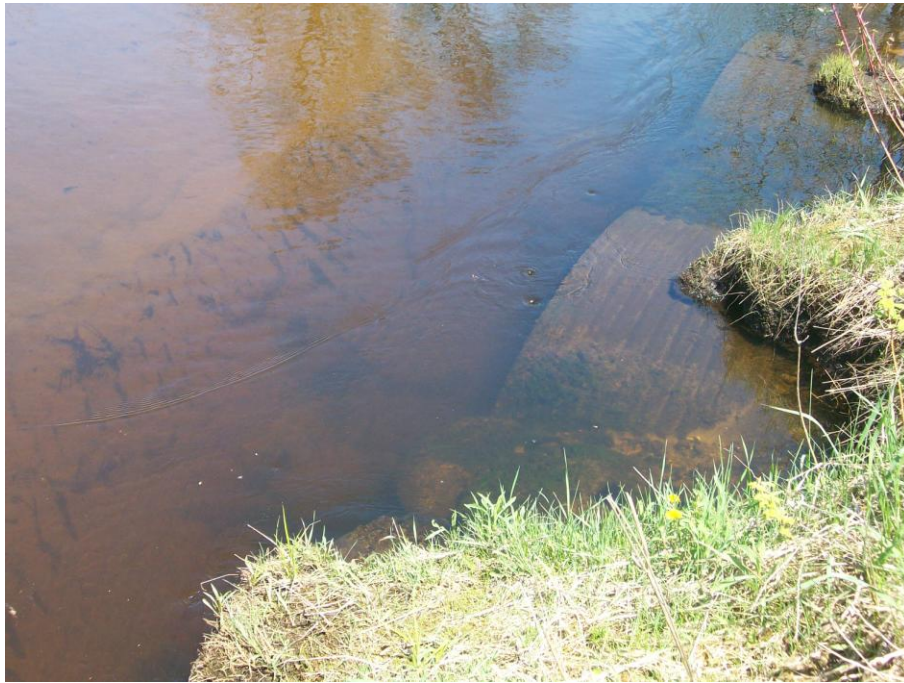
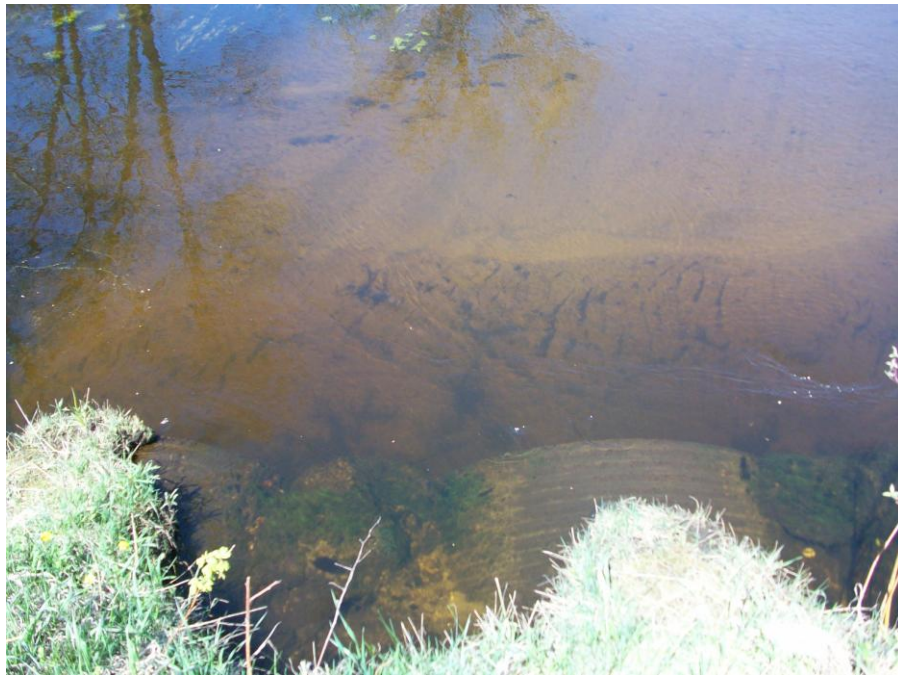
BEFORE- Impounded sediments cascade into the undersized culverts at Mecum Road and North Branch Manistee River. The 5 culverts shown are 72" diameter and pictures depict the stream bed elevation aggraded to the top of the tubes. The approaches are composed of sand and gravel that also input to sediment delivery.

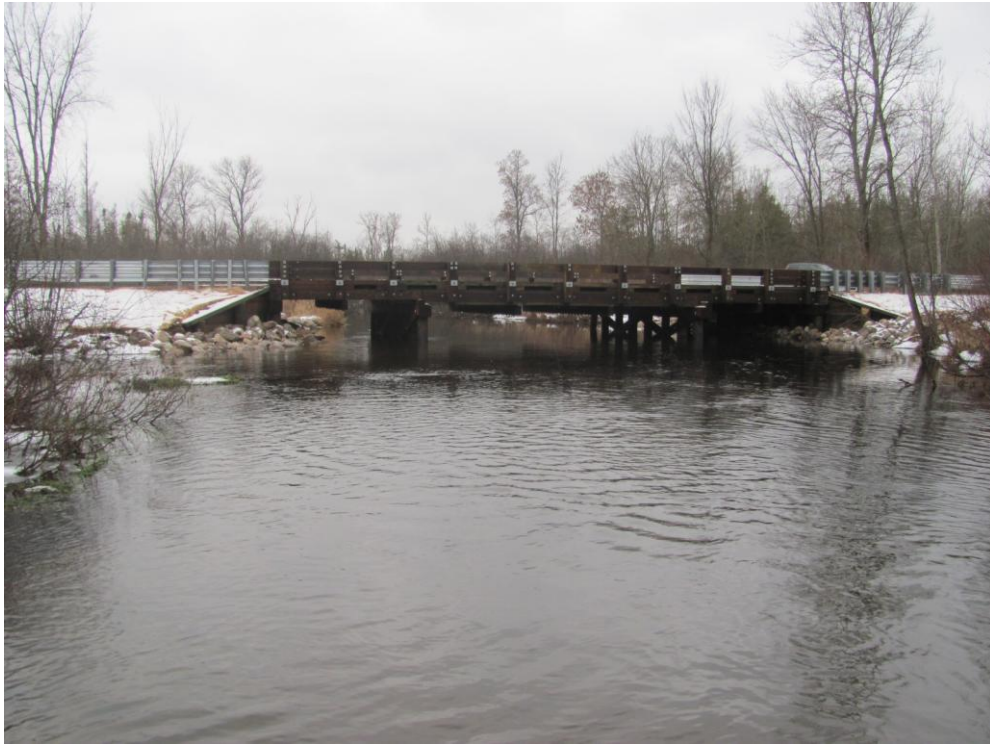
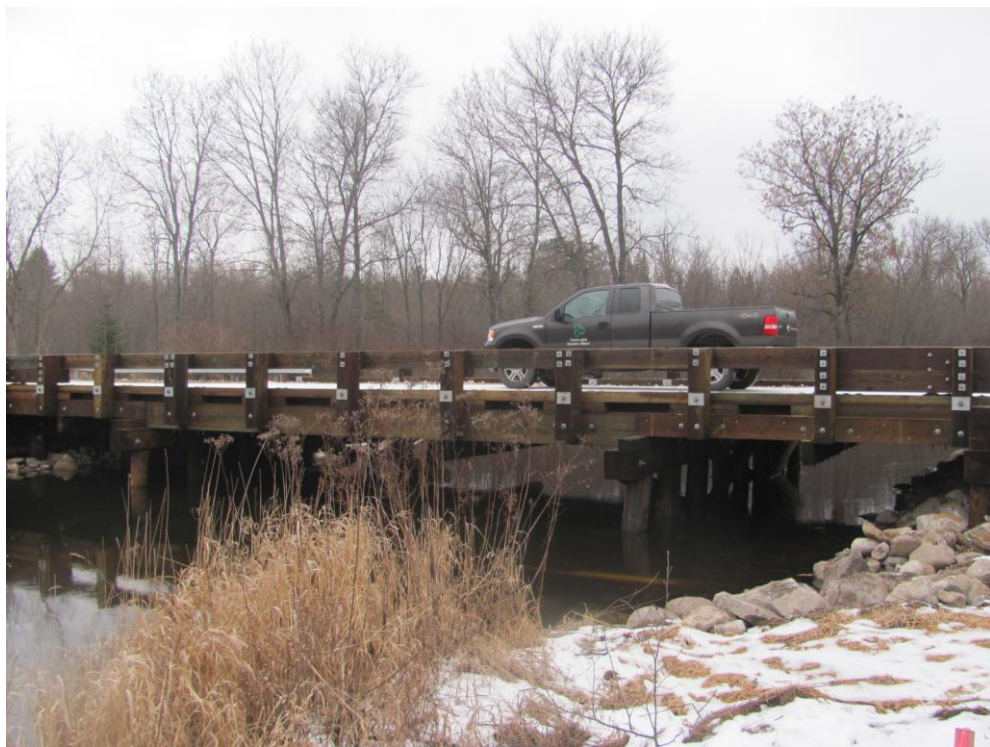
AFTER - Channel spanning timber structure allowing for unrestricted aquatic species passage and sediment and nutrient movement.
