Platte River & Reynolds Road Bridge

2012

The Platte River is a State designated Blue Ribbon Trout Stream, and includes 90.5 miles of stream and tributaries. The Reynolds Road crossing on the Platte River mainstem (site #PLT-A4) was a severe site where the 4' diameter culvert was exceptionally undersized. As a result, the road embankments were eroding and slumping into the stream and pool formation was a problem at the outlet. These conditions were exacerbated by intense recreational use, and steep, curved road approaches with limited visibility on a well traveled road. People built a rock dam completely across the river at the artificial pool that widened the river, and trampled the embankments in order to get to the river. The altered channel warmed water temperatures and caused trees on the streambanks to collapse into the stream further impeding flows. Now, a timber bridge fully spans the river and a realigned roadway provides safer conditions for drivers.

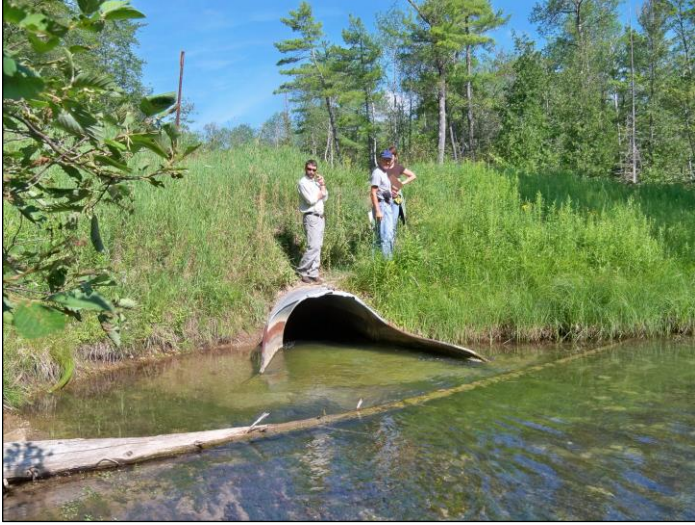
Inlet – “Before”

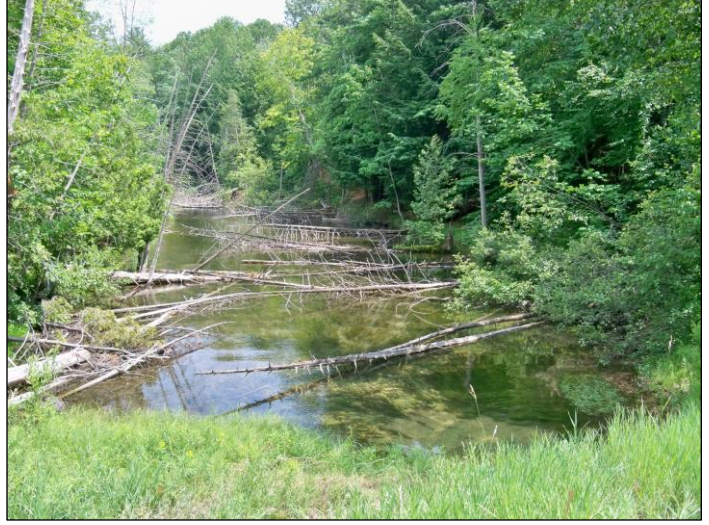
Looking upstream –
Impounded water widened the channel

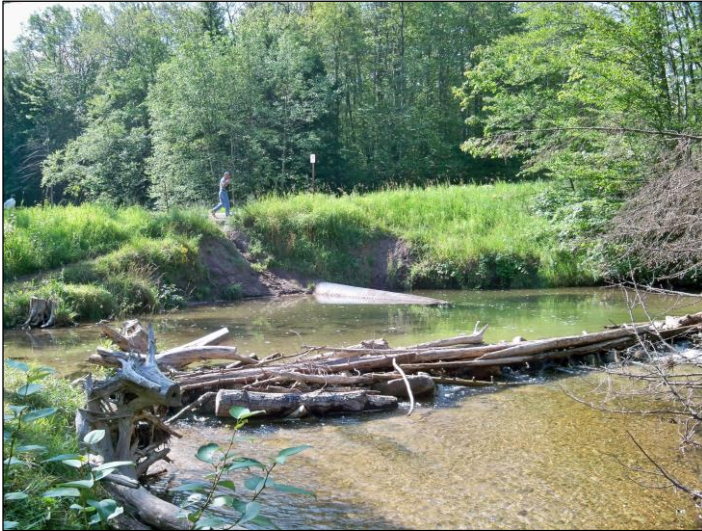
Outlet – “before” pool formation at the outlet was exacerbated by recreational use

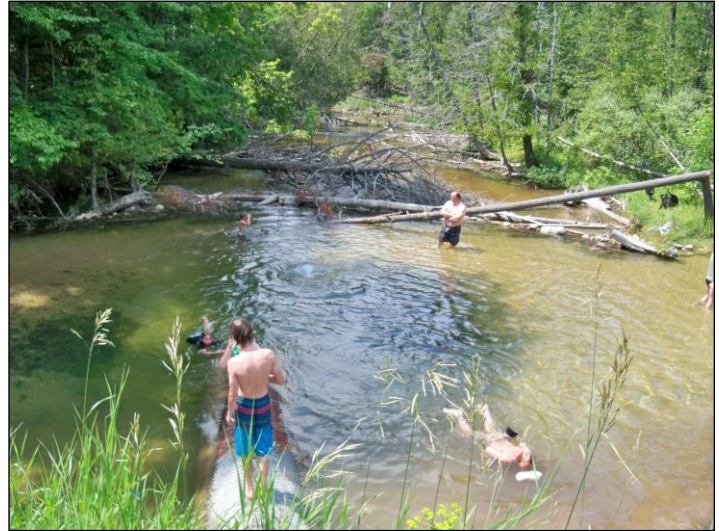
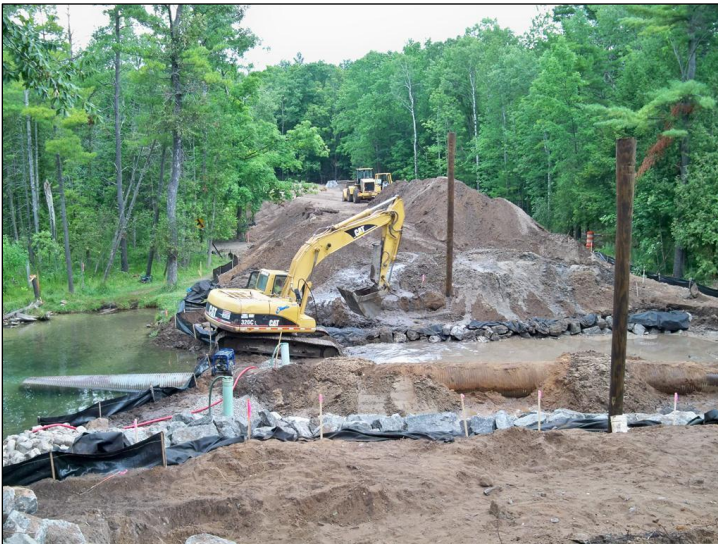
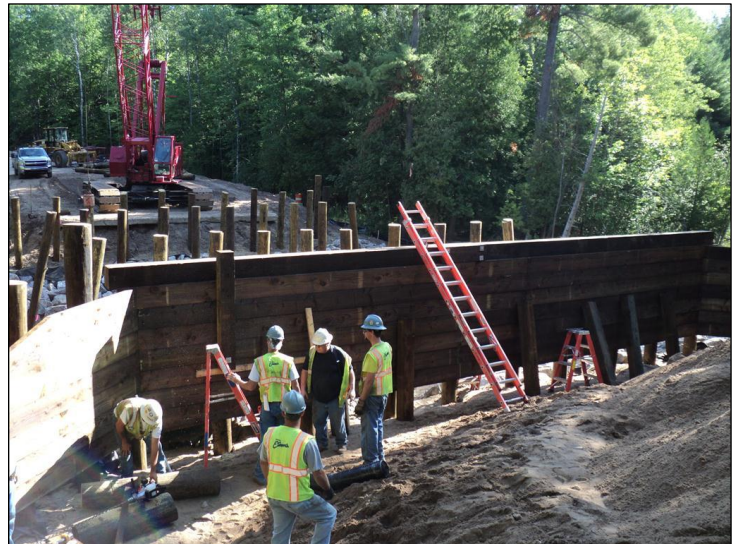
During construction

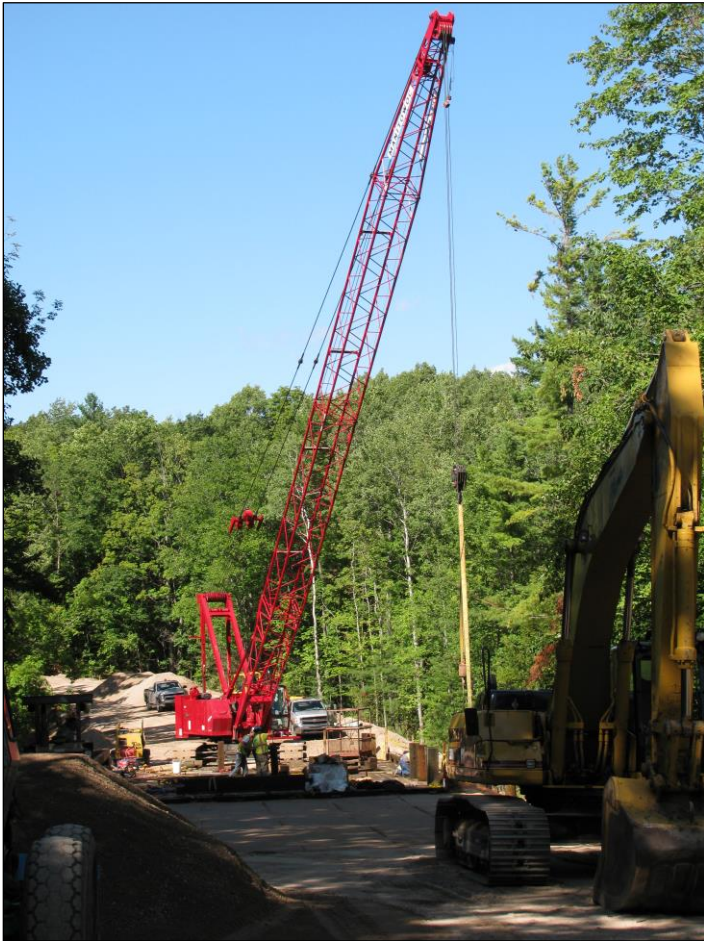
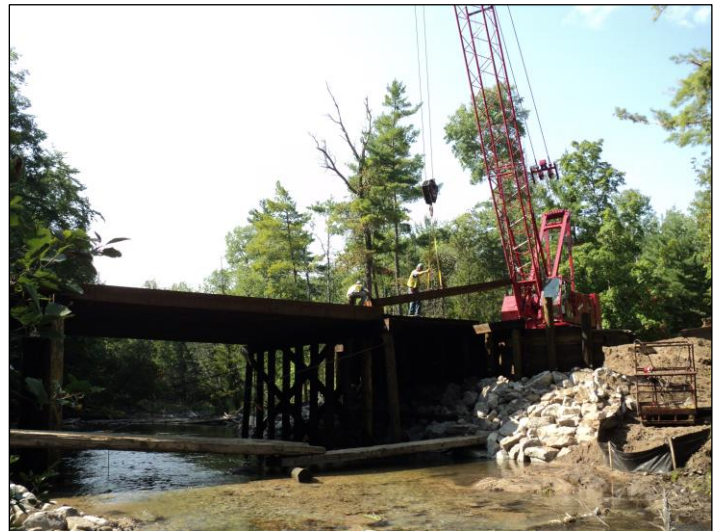
Pile driving & deck setting - the bridge was set on 48 piles driven over 20' into the ground

- Replace 4' diameter, 98' long corrugated steel culvert with a 66' long, 34' wide, 3 span timber bridge set on 48 piles driven over 20' deep into ground
- 500' guardrail
- Installation of 7 spillways & 2 downspouts to route runoff
- Realignment, grading, paving & curbing of 1,200' of road approaches
- Rock placement & revegetation

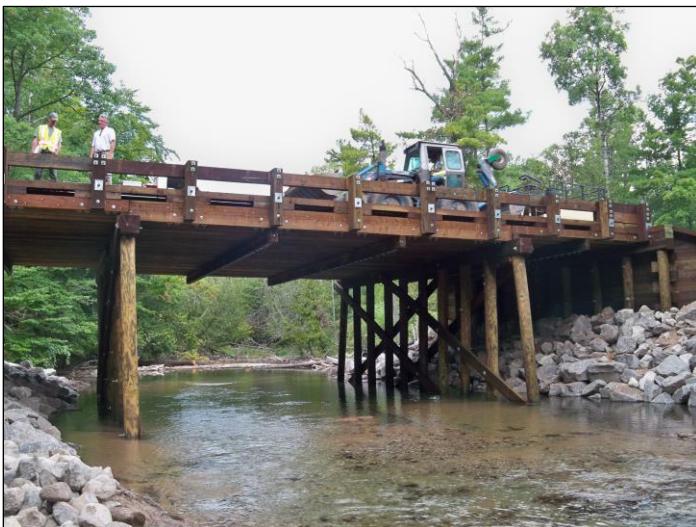
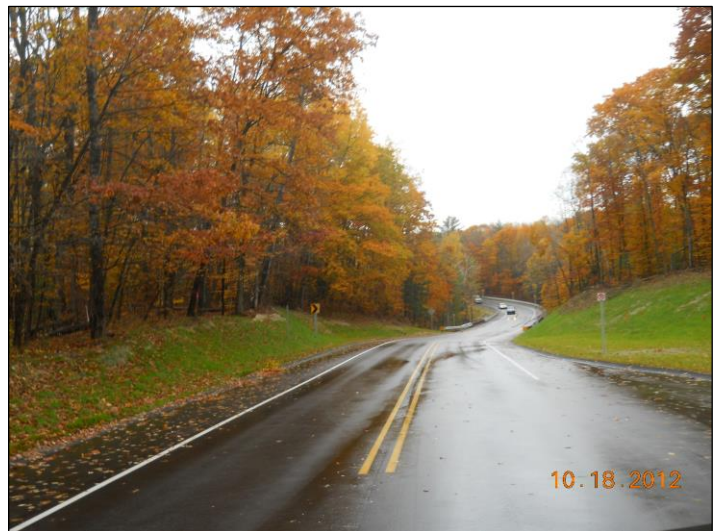
Rock protects abutments from scouring & 1,200' of approach work improves safety & channels road runoff
